## **Basin Study and Prioritization Report**

Cold Creek Culvert Replacements and  
Channel Stabilization Project  
Federal Way, Washington

*for*  
**City of Federal Way**

April 18, 2022

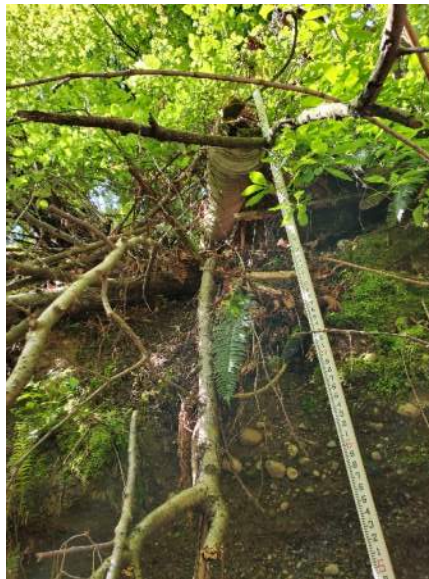
Three stormwater inputs were observed, one near Sta 6350 and two at Sta 6050, just upstream of the Dash Point Road crossing (Figure 3). The stormwater pipe at Sta 6350 was a 12-inch corrugated metal pipe (CMP) that appeared to lie on top of the hillslope but protruded approximately 3 feet from the top edge of the hillslope (Photo 1). It has created a 12-foot-high vertical bank below it as the hillslope has eroded due to the excess water input.

Photo 1: Stormwater input at Sta 6350 forming 12-foot-high headcut bank

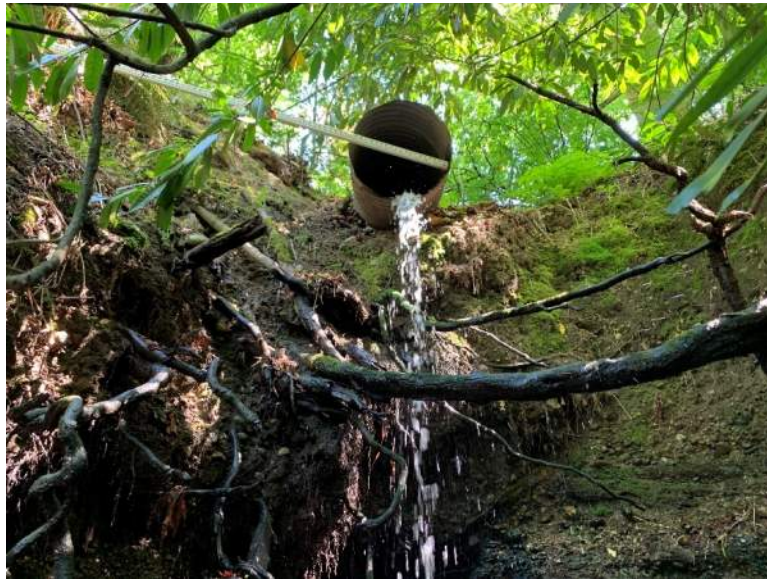
Two stormwater inputs near Sta 6050 were observed directly upstream of Dash Point Road on the right bank looking downstream. The first is a 24-inch CMP that is at least partially buried in the hillslope. It forms a 14-foot-high vertical bank and has scoured a path 10 feet in top width approximately 20 feet into the hillslope (Photo 2). The second is a 12-inch CMP protruding from the road base spilling onto riprap (Photo 3). A flume was observed bent and twisted in the jumble of riprap that may have once conveyed water from this pipe. Currently, there is a 2-foot-wide and equally deep incised channel beneath downed tree limbs and roots that appeared to convey water, although none was flowing at the time of the field visit.

*Photo 2: Stormwater pipe at Sta 6050 with 14-foot-high headcut bank*

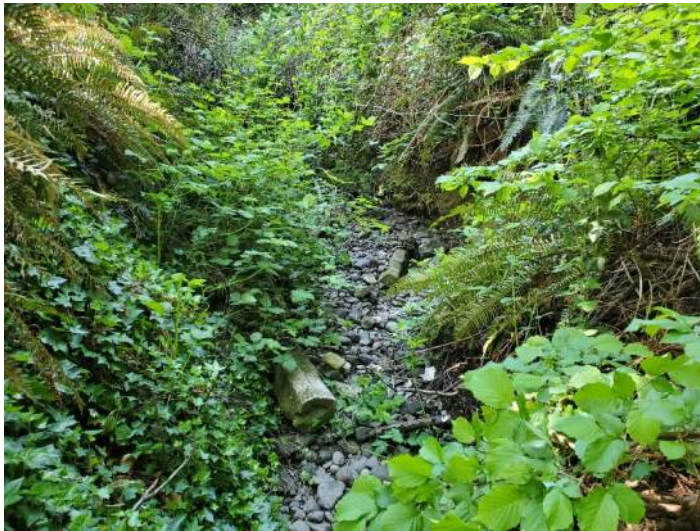
*Photo 4: Incised condition.*

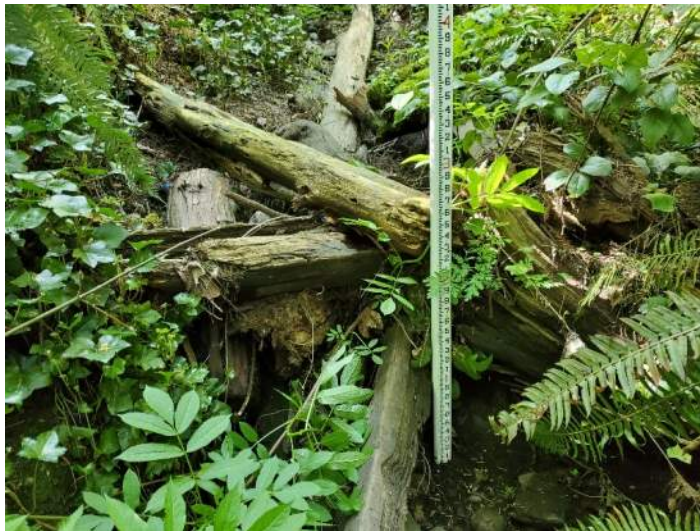
*Photo 5: Wood step with modified wood.*

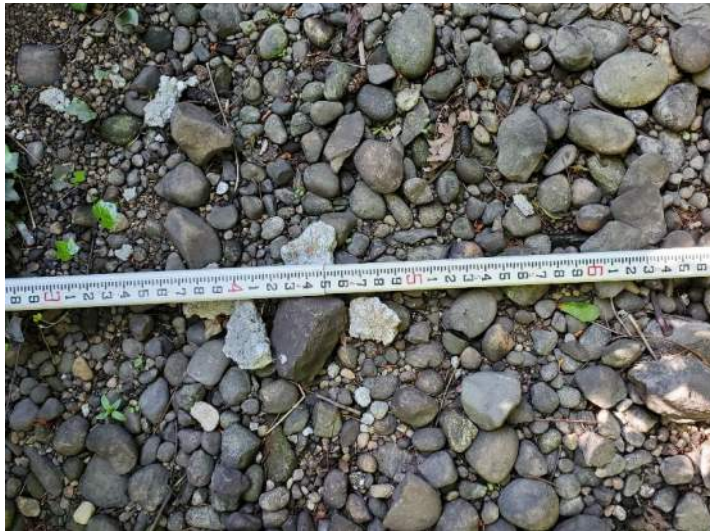
The sediment in the channel near the stormwater outlet appeared more angular than typical for streambed material, suggesting it was added to the system at some point in time (Photo 6). Elsewhere, bed material appears to have been derived naturally and ranges from coarse sand to boulders with large gravel as the dominant material (Photo 7). There was a clear deficiency of fine-grained material in the bed material even though it is abundant in the banks, suggesting fine material is easily carried out of this upper portion of the system.

*Photo 6: Sediment near outlet and lack of material finer than coarse sand.*

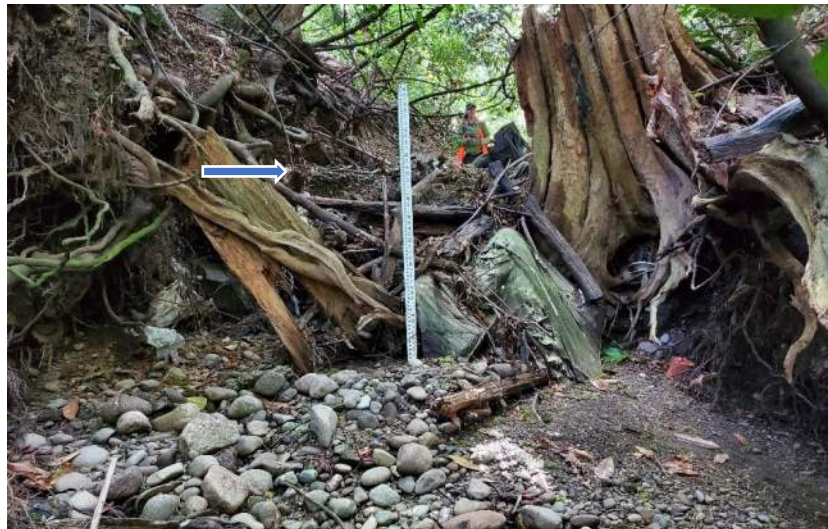
*Photo 10: 3-foot step, incision above and below step; blue arrow points to streambed upstream of the step.*

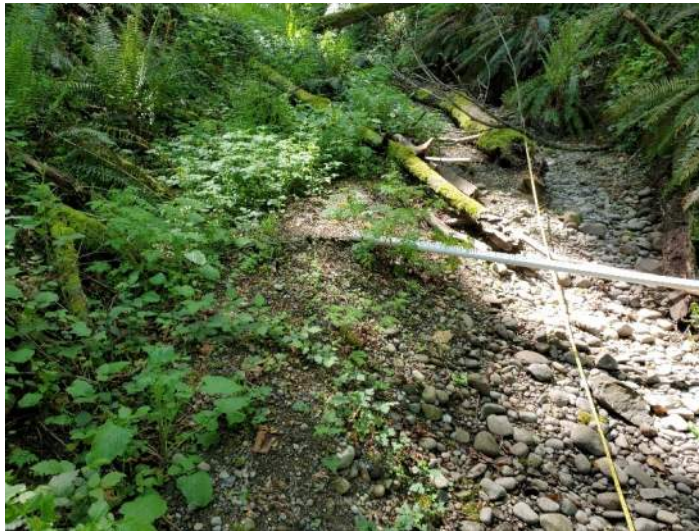
*Photo 11: Reference reach with slightly wider valley bottom than further upstream and narrow fluvial surface.*

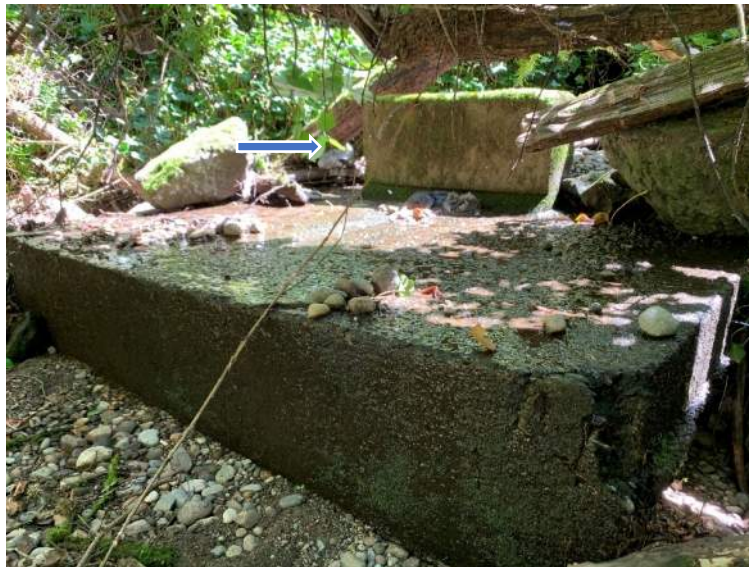
*Photo 12: Concrete apron and flow dispersion structure (arrow). Apron has been flanked on both sides.*

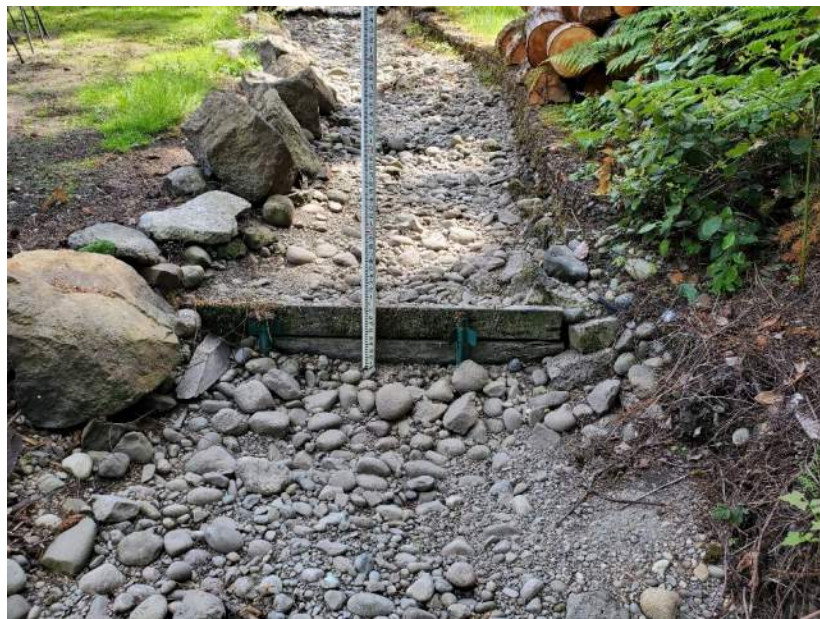
*Photo 16. Additional channel modifications in downstream portion of Reach 2.*

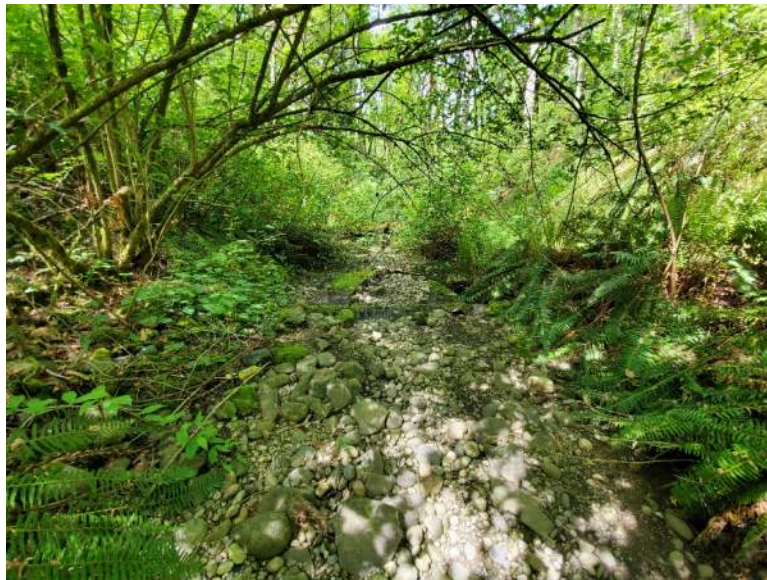
*Photo 17. General channel and vegetation conditions looking downstream along Reach 3.*

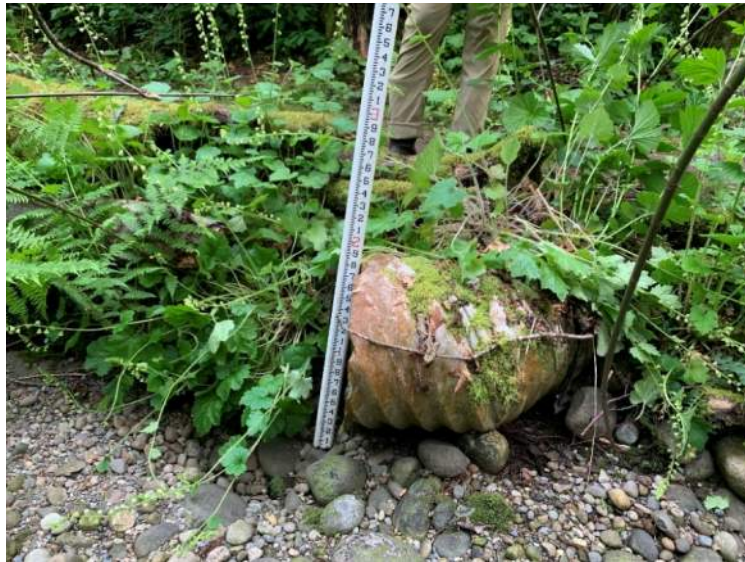
A single stormwater input is observed in this reach other than that entering the creek at the junction in the catch basin just downstream of the pool. The stormwater pipe is an 18-inch CMP that follows the hillslope until it gets near the stream where it goes vertical adjacent to the trail before flattening to go underneath the trail, after which it is angled slightly downstream as it enters the stream (Photo 18).

*Photo 18: Stormwater input on right bank.*

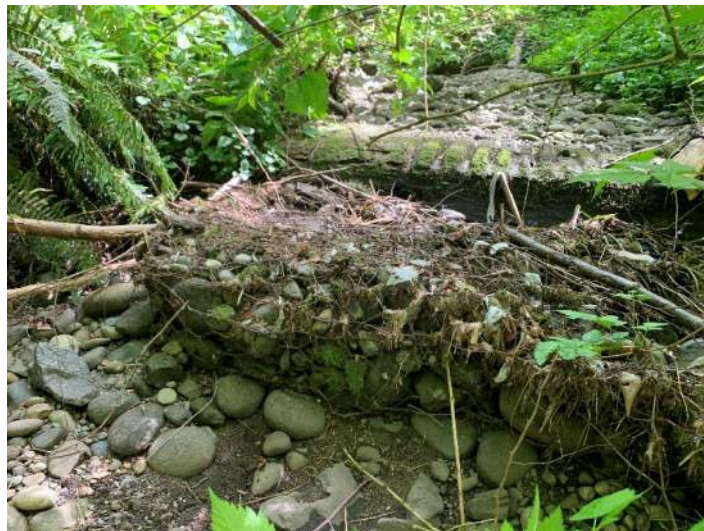
*Photo 19: Notched log with wire gabion basket downstream.*

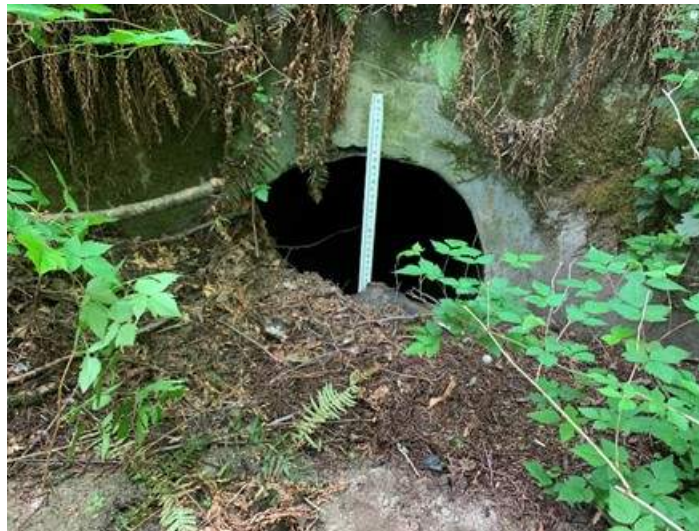
*Photo 21: Unmapped culvert inlet, half blocked by debris, sand deposited upstream of inlet.*

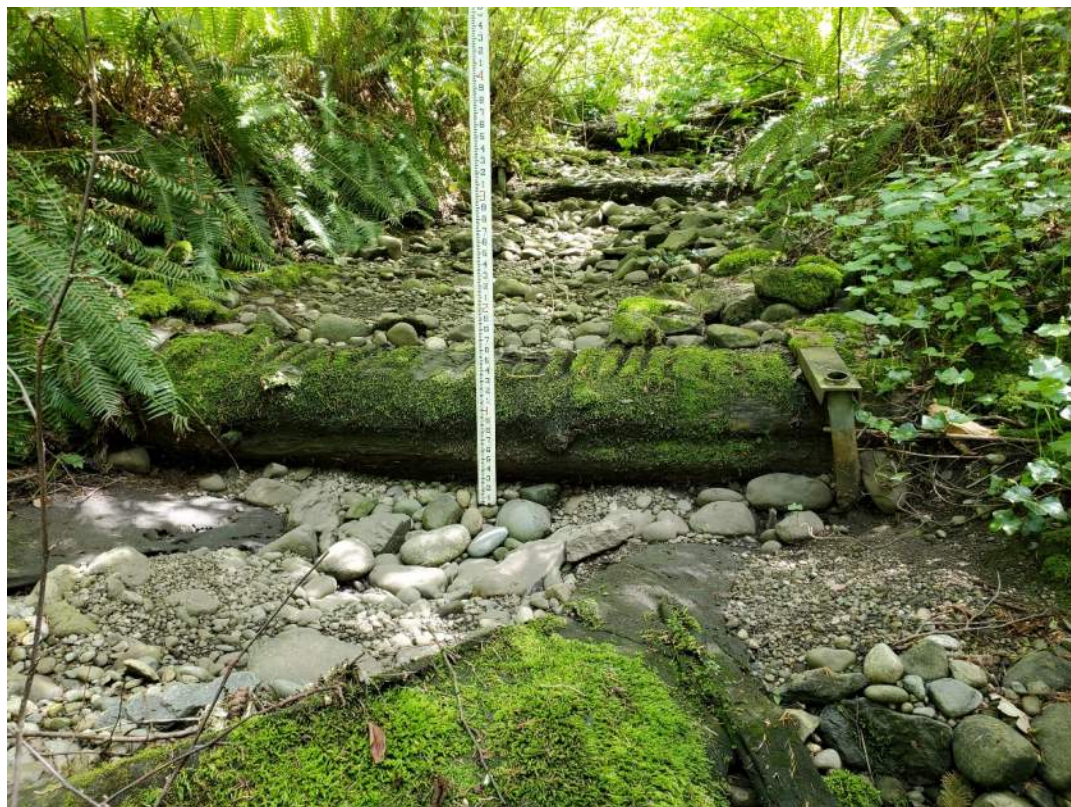
*Photo 23. Series of log steps with moderate-sized scour pools and occasional exposed geotextile fabric.*

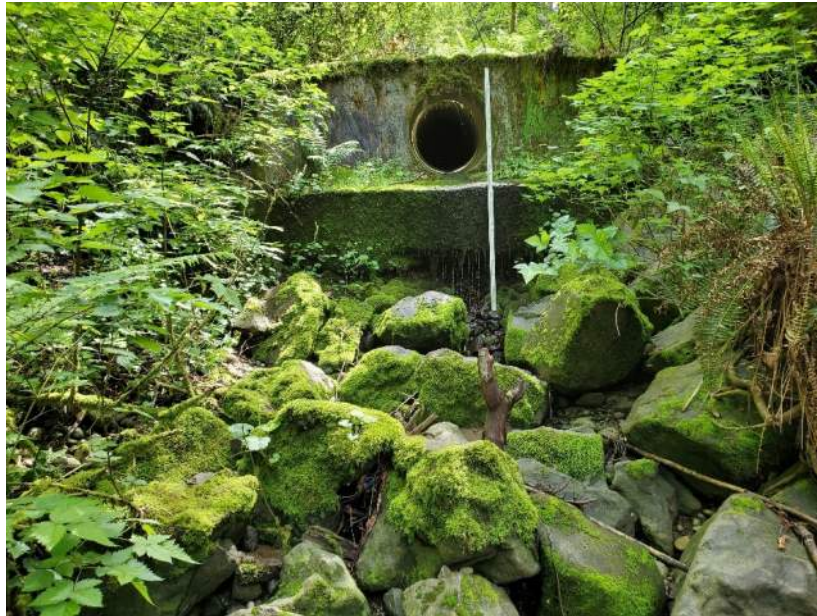
Photo 24: Outlet of unmapped culvert with boulder cascade. Apron is 2 feet thick. Refer to Photo 21 for view of inlet to this culvert.

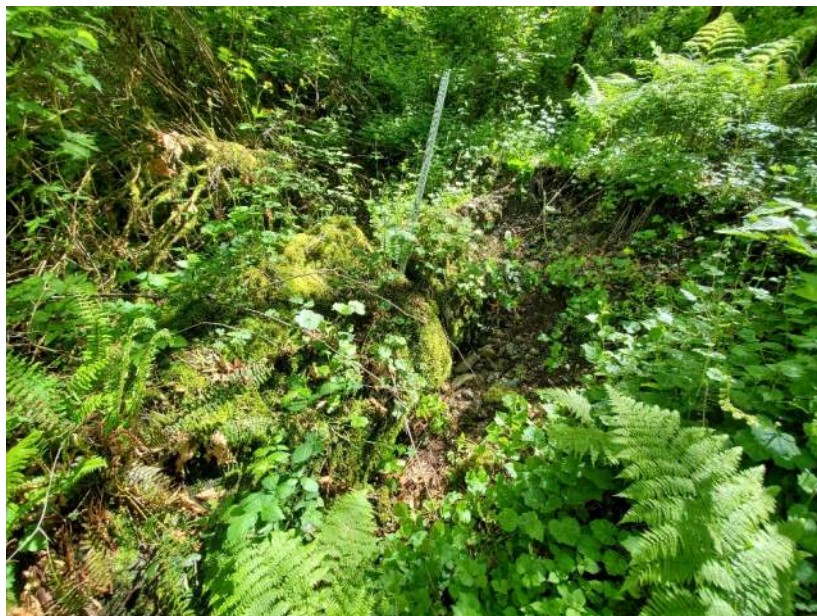
- Unmapped culvert in ravine (between Reaches 3 and 4): Not assessed by Coffman Engineers; however, GeoEngineers observed that several sections of concrete pipe at the downstream end of the culvert had failed and separated from the upstream portion of the culvert.

Photo 25: Separation of concrete pipe sections (marked with stadia rod) and erosion upstream of unmapped culvert outlet.

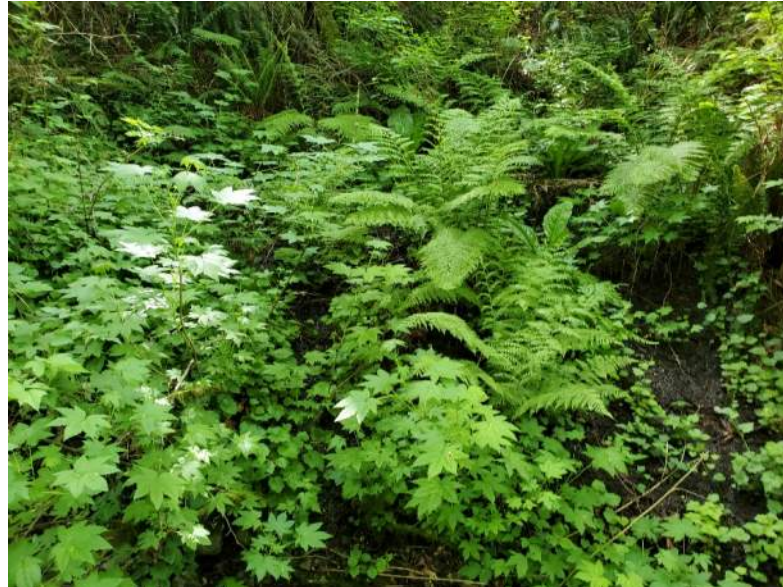
*Photo 26. Frequent hillside seeps along channel banks.*

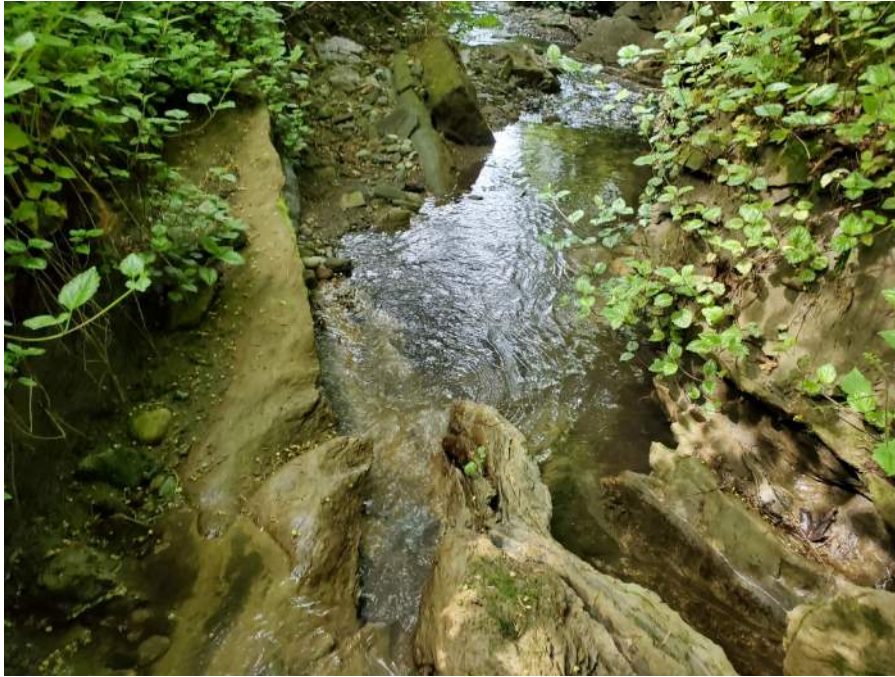
*Photo 32: Tilted varved clays and silts.*

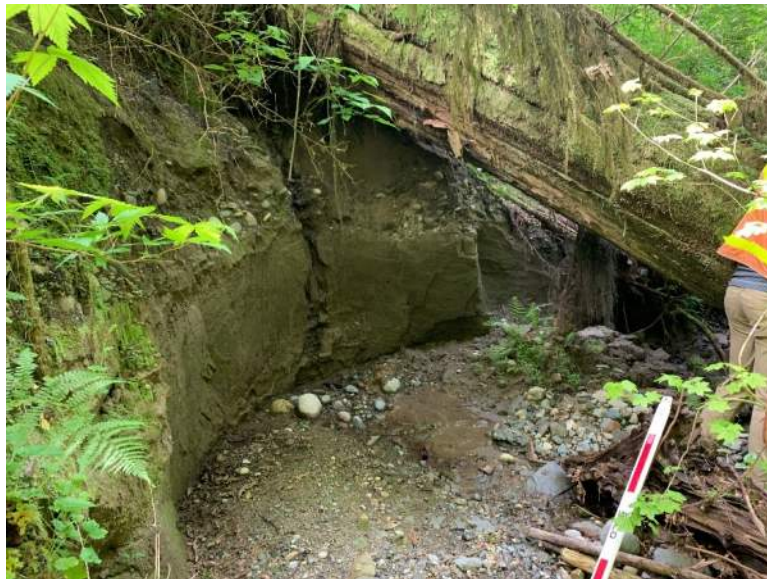
*Photo 34: Erosion along valley wall, creek is to right of photo looking downstream.*

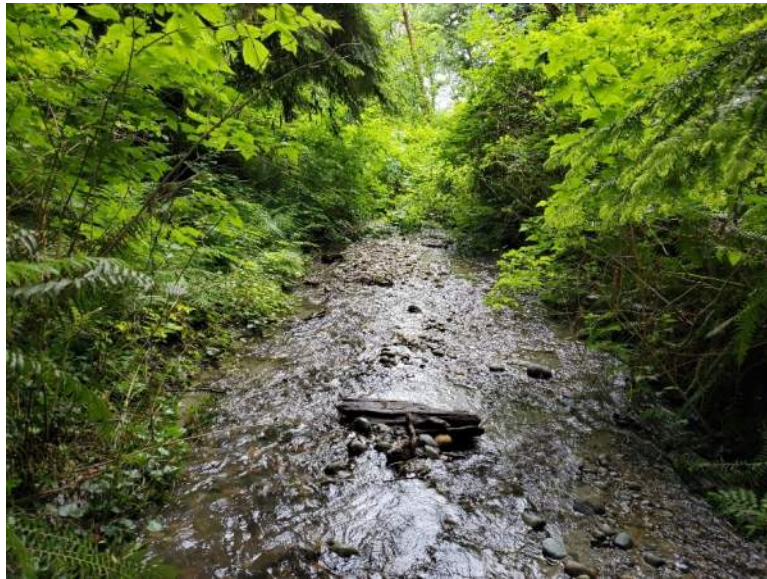
From Sta 2600 to Sta 2200, the creek may currently be widening as significant lateral scour was observed, resulting in deposition of fine-grained material in the channel. Deposition of landslide material from approximately Sta 2200 to Sta 1600 is the likely cause for the rise in elevation of the profile relative to the equilibrium slope in Figure 5. Widening has occurred but the more dominant process may be aggradation as sediment is trapped behind numerous log jams in this reach (Photo 35).

*Photo 35: Deposition in channel, accumulation of sediment in middle of channel.*

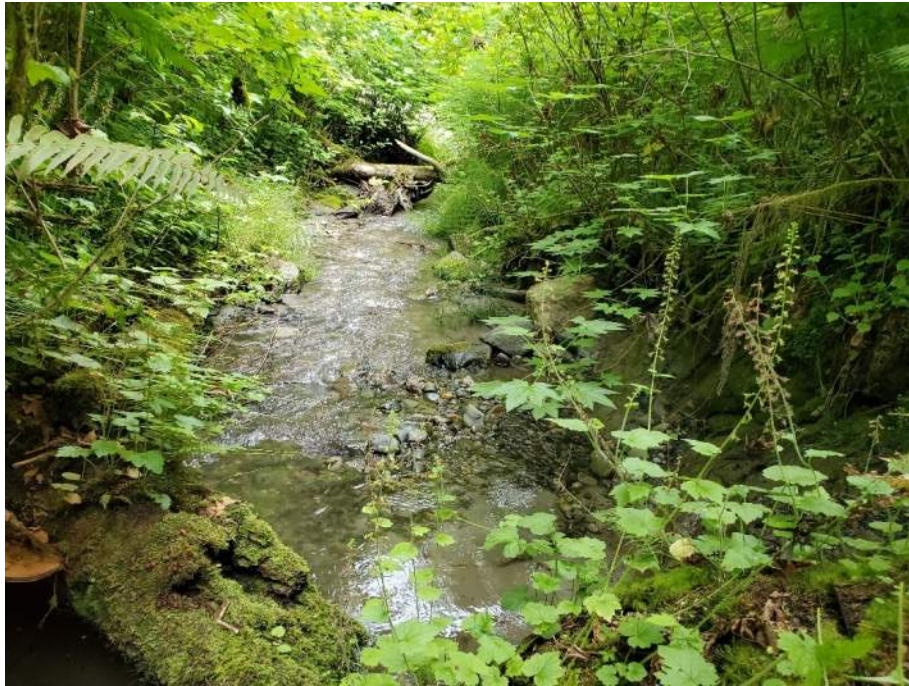
*Photo 37. Quality habitat within reach featuring pools, riffles, large wood and dense overhanging vegetation.*

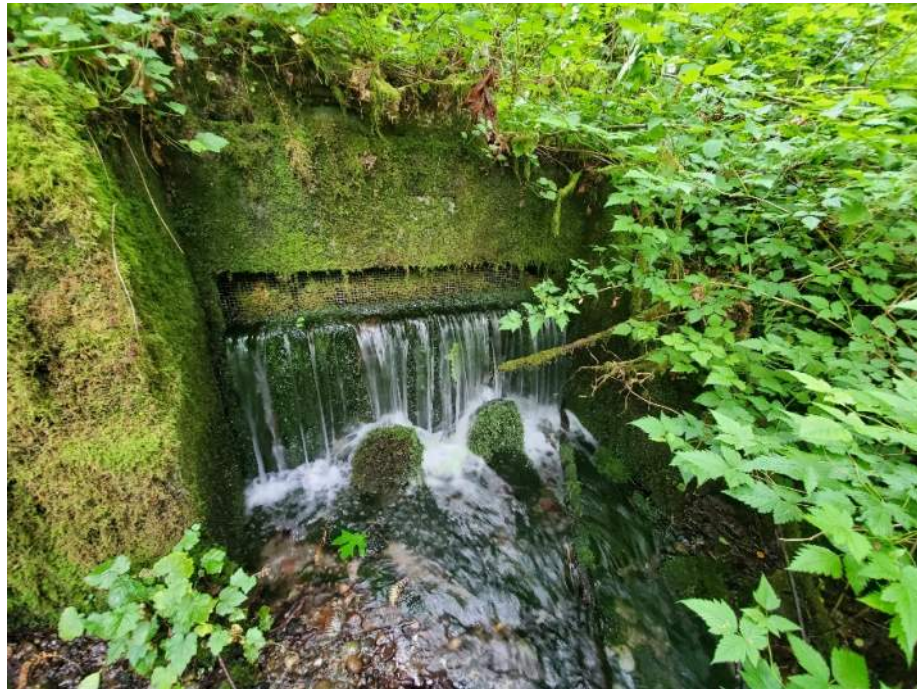
*Photo 38: Cold Spring vault.*

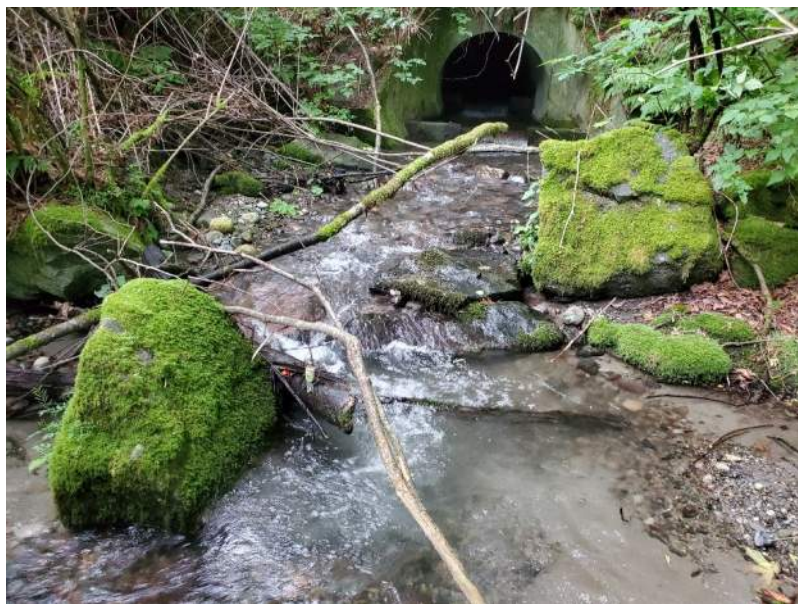
*Photo 41. Baffled wastewater treatment plant culvert outlet.*

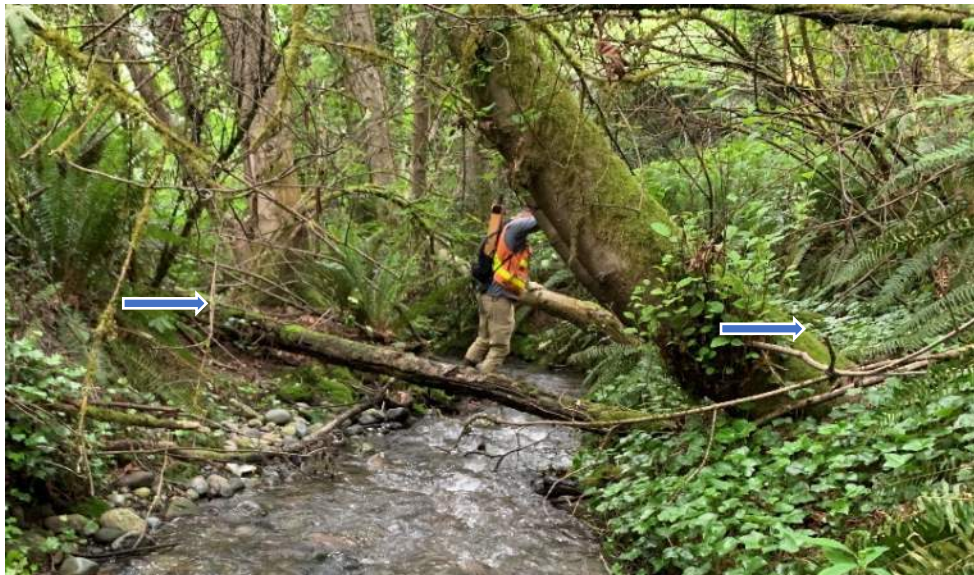
*Photo 44: Arrows identify inset fluvial surfaces.*

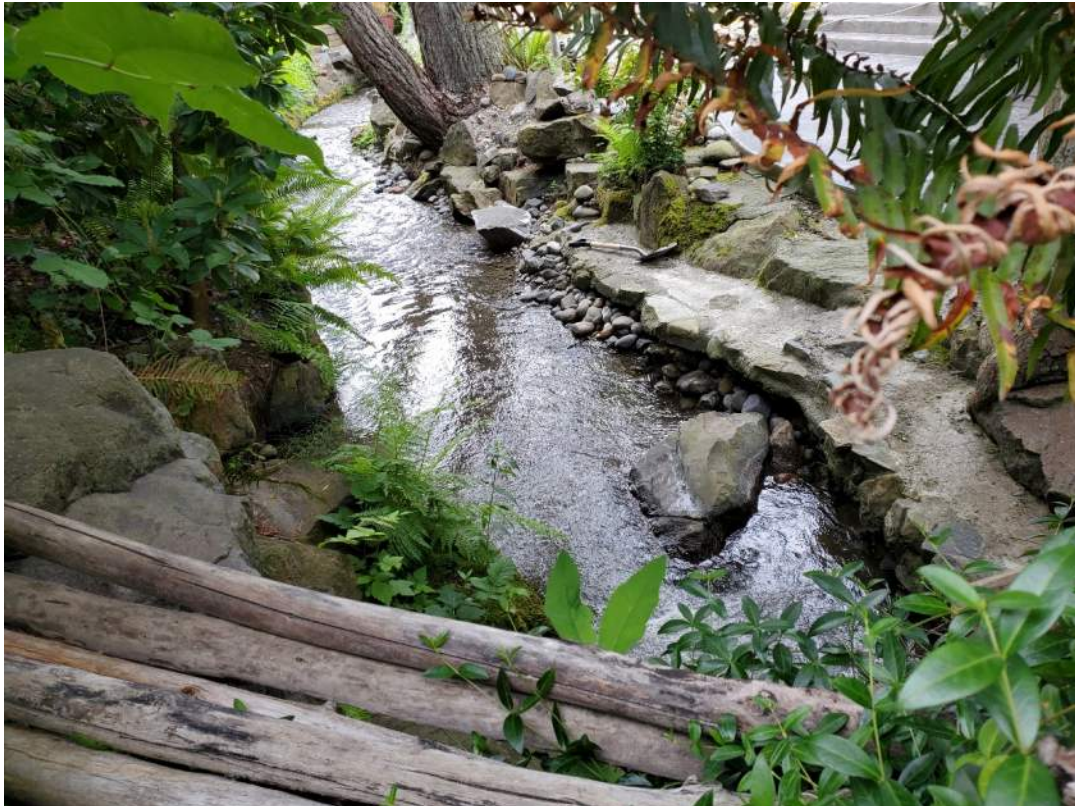
*Photo 49: Hardened channel edges*

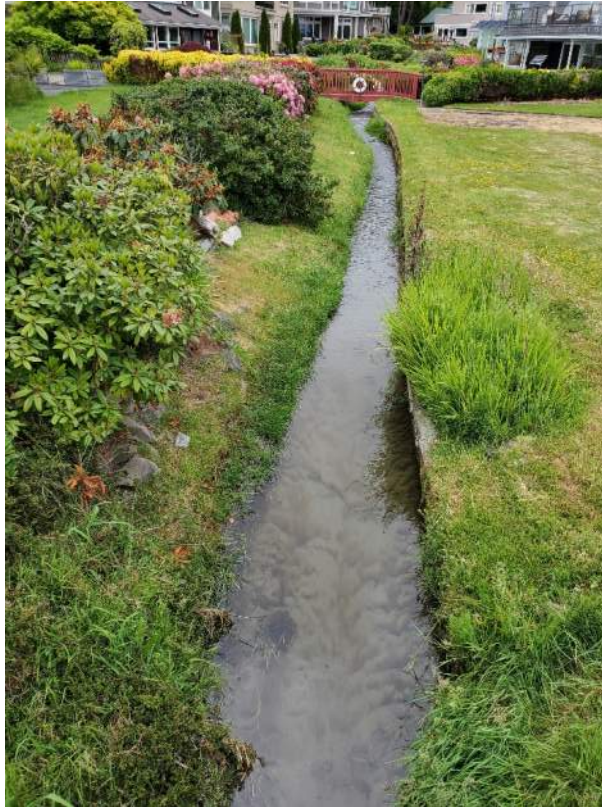
*Photo 50: Highly modified channel conditions within reach.*

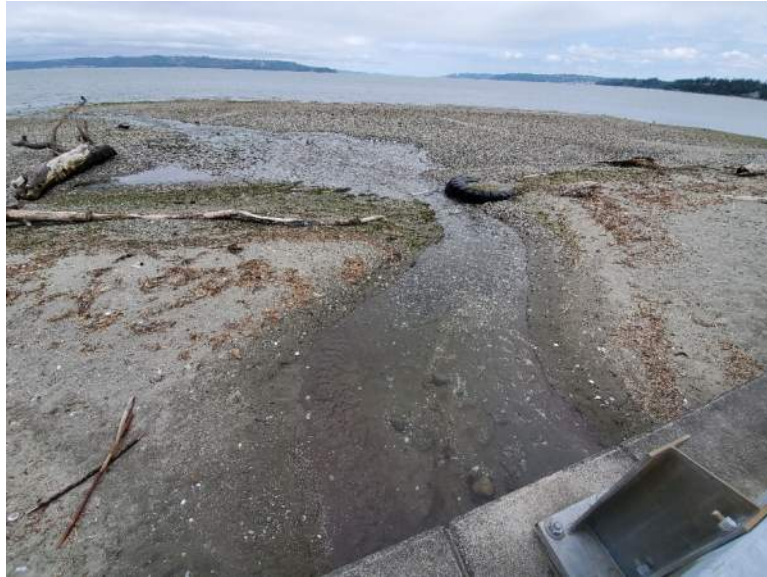
*Photo 51: Delta at Puget Sound/Poverty Bay*

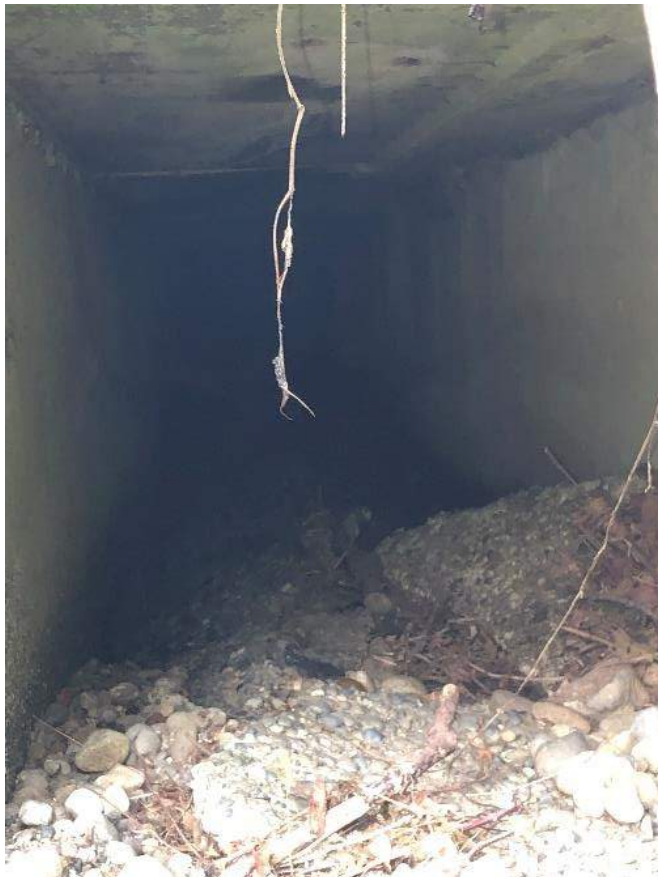
*Photo 12 Marine Hills ID # 19017 Inlet Bore bottom slab broken pieces.*

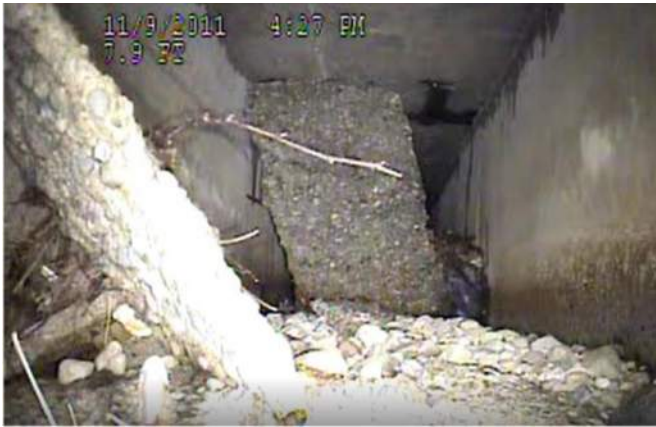
Photo 13 Asset ID # 21520 Broken bottom slab concrete stuck in bore looking upstream at 7.9 feet.

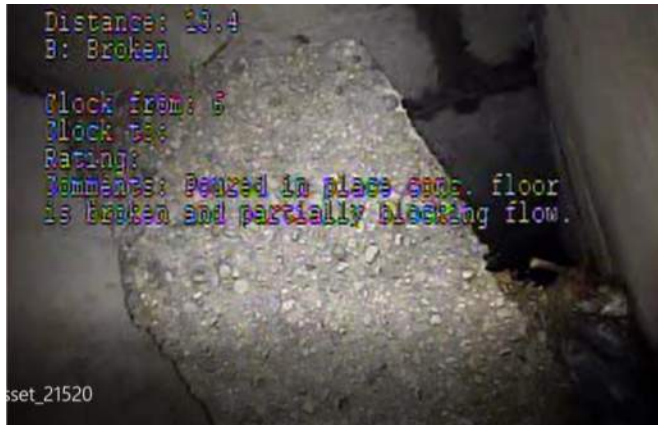
Photo 14 Asset ID # 21520 Broken bottom slab concrete stuck in bore.

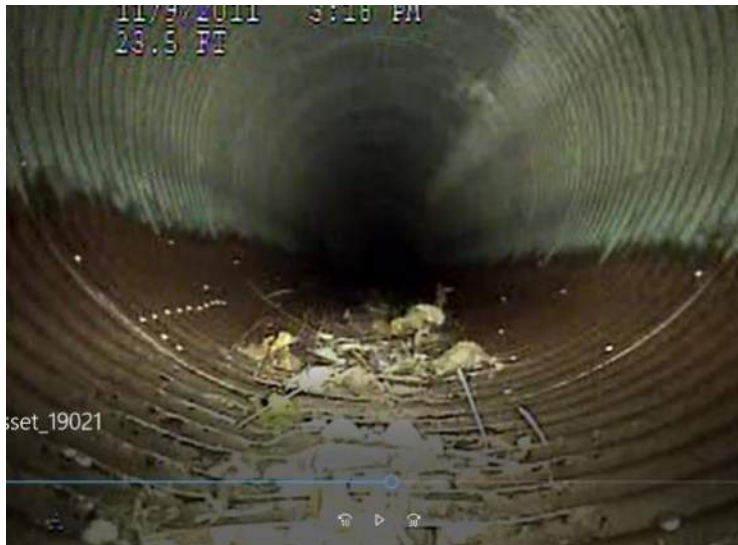
Photo 15 Typical heavy corrosion in CMP invert. Note the holes in the invert.

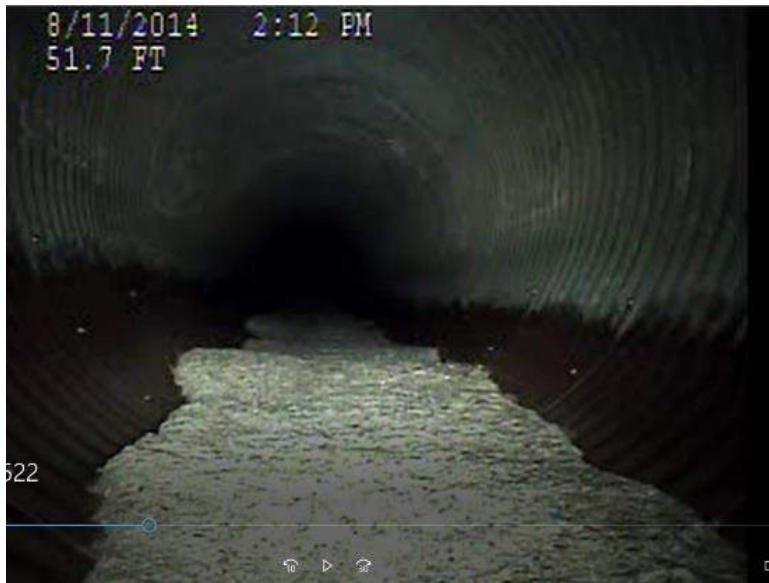
*Photo 16 Typical concrete bottom liner for corrosion repair in CMP.*

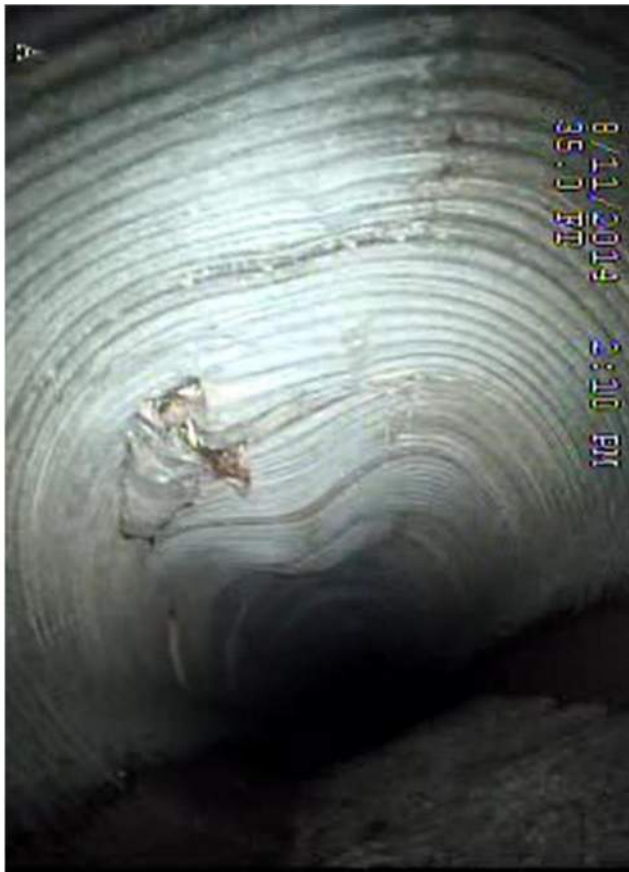
*Photo 21 Asset # 21522 Crown damage at 35 feet. Hole torn in crown.*

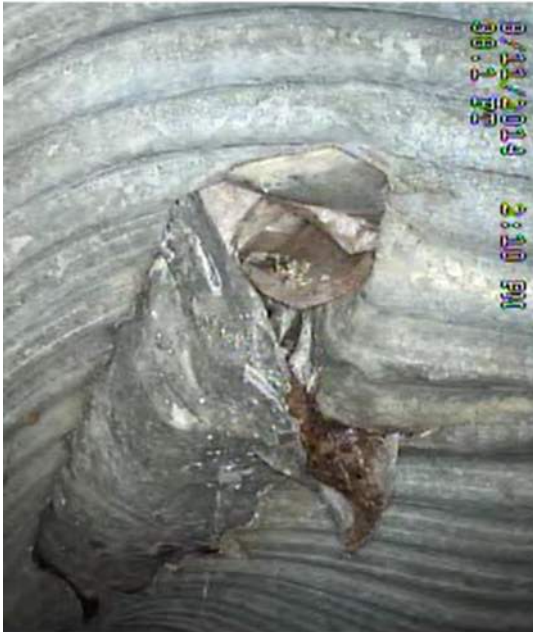
*Photo 22 Asset # 21522 closeup of torn hole and debris.*

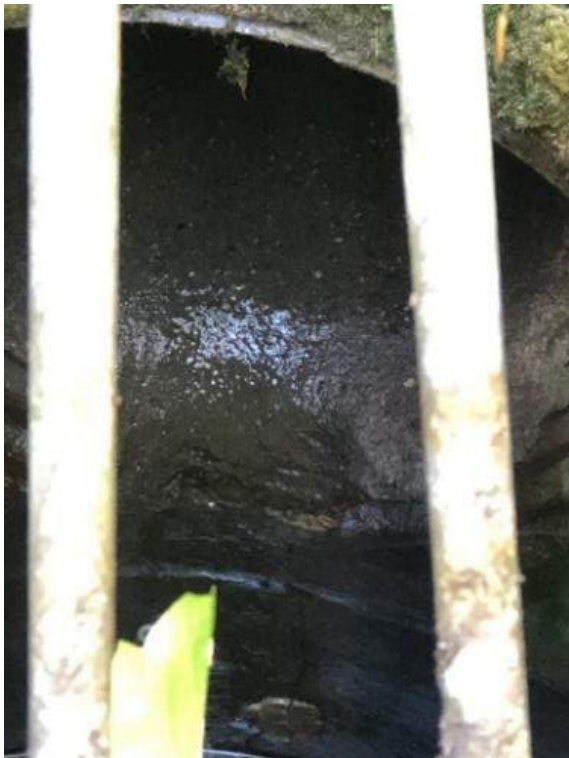
*Photo 25 Outlet of Asset ID # 21522 between Asset ID # 21522 and ID # 21523. CMP Concrete Repair of Invert.*

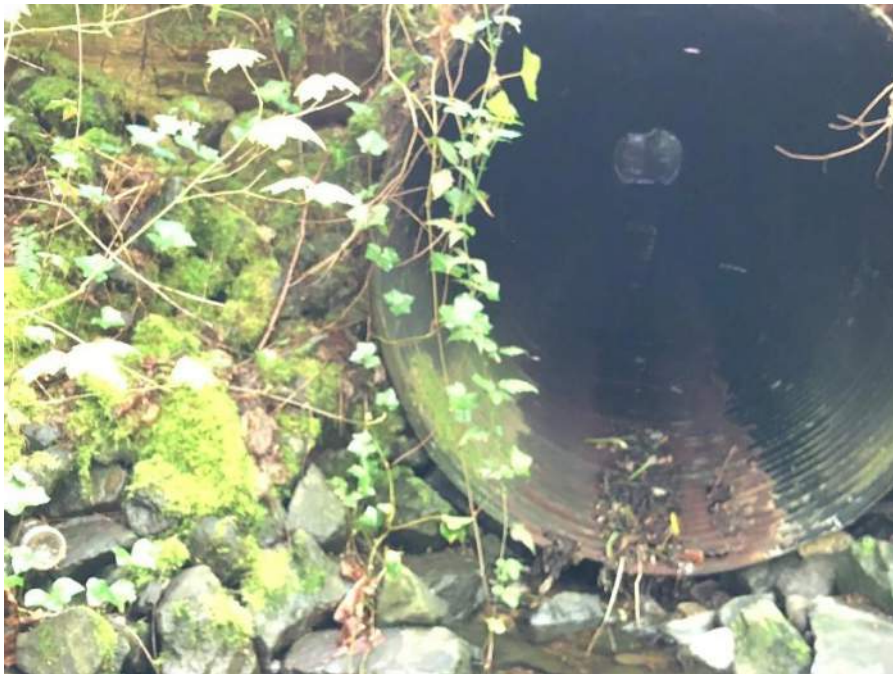
*Photo 27 Outlet Asset ID 21523 corrosion at invert.*

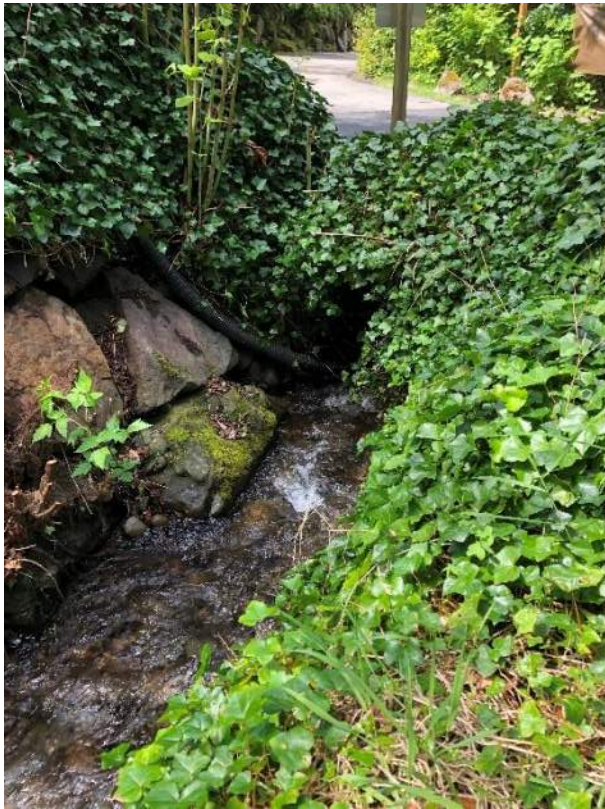
*Photo 28 Redondo Shores Dr. S. inlet covered by vegetation.*

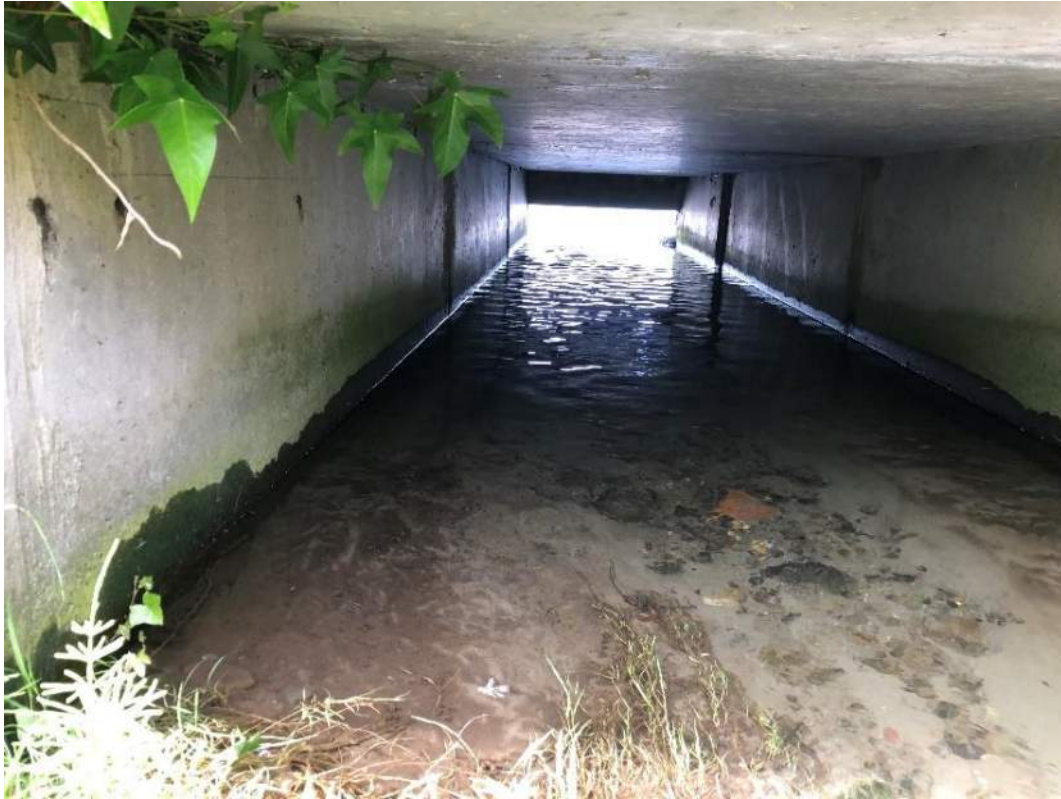
*Photo 32 Redondo Beach Dr. S. inlet and bore.*
