## **Basin Study and Prioritization Report**

Cold Creek Culvert Replacements and  
Channel Stabilization Project  
Federal Way, Washington

*for*  
**City of Federal Way**

April 18, 2022

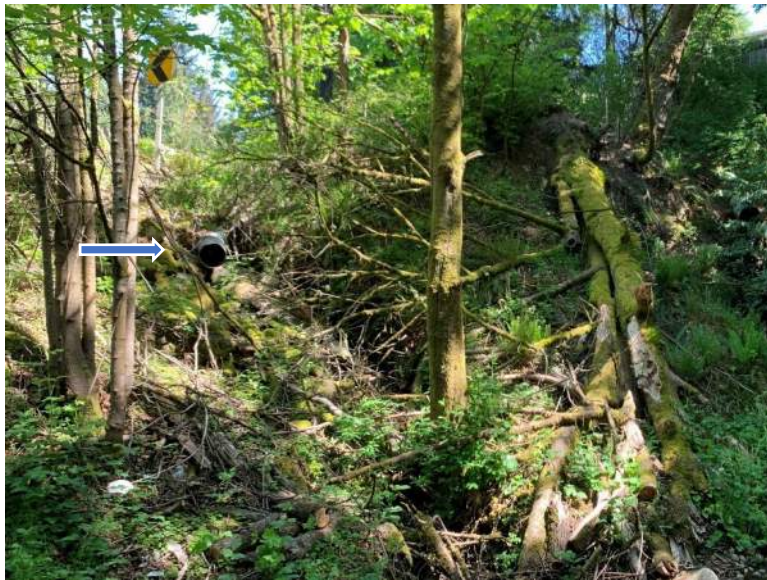
Two stormwater inputs near Sta 6050 were observed directly upstream of Dash Point Road on the right bank looking downstream. The first is a 24-inch CMP that is at least partially buried in the hillslope. It forms a 14-foot-high vertical bank and has scoured a path 10 feet in top width approximately 20 feet into the hillslope (Photo 2). The second is a 12-inch CMP protruding from the road base spilling onto riprap (Photo 3). A flume was observed bent and twisted in the jumble of riprap that may have once conveyed water from this pipe. Currently, there is a 2-foot-wide and equally deep incised channel beneath downed tree limbs and roots that appeared to convey water, although none was flowing at the time of the field visit.

*Photo 3: Stormwater input at Sta 6050; incised conveyance channel leads from outlet toward lower center of photo and then down to the left of the standing tree in the center of photo.*

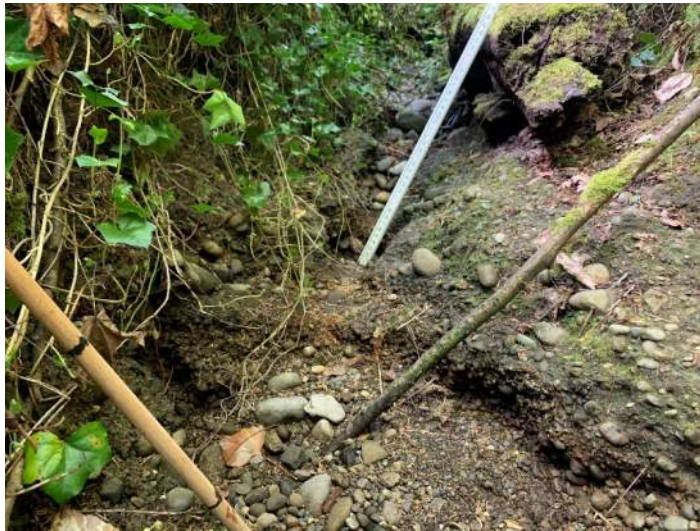
*Photo 8: Looking upstream: scour and headcutting, exposing underlying geologic material.*

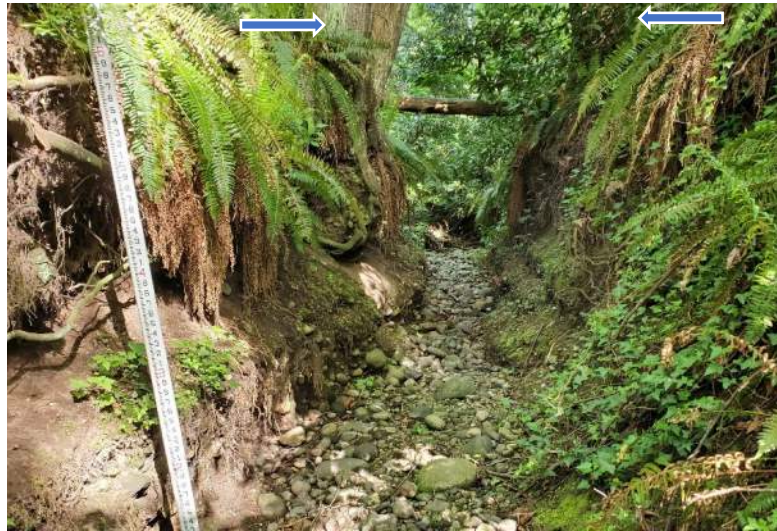
*Photo 9: 6 feet of incision over time; approximately 2 feet of recent incision illustrated by vertical banks at edge of creek. Arrows indicate large trees that were once at the edge of and near the same elevation as the creek.*

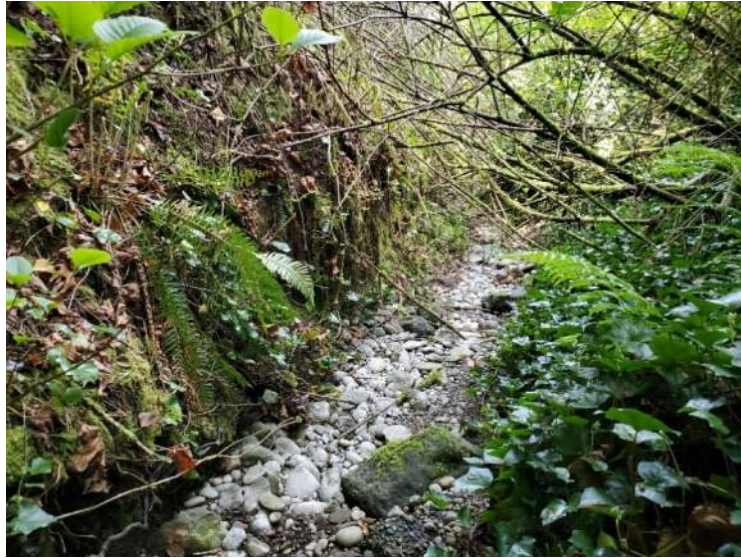
The riparian corridor within Reach 2 is even more constricted than upstream, averaging less than 100 feet wide at the top. The Dash Point Road fill prism extends nearly to the left channel bank to the south, while fill slopes below houses similarly extend to the creek on the north. Ivy dominates most of these slopes and has grown over many trunks of the fir, alder and maple canopy. The upstream half of the channel is covered by a dense shrub layer of salmonberry (*Rubus spectabilis*), red elderberry (*Sambucus racemosa*) and laurel (Photo 13). The lower half of the reach features flat benches adjacent to the channel utilized by landowners for recreation, including firepits, firewood prep and storage, and small tables and benches (Photo 14). Grass, ferns and ivy are the dominant vegetation in this lower section, with limited overhead cover provided by trees 30 to 50 feet from the channel to the south.

*Photo 13. Upstream portion of Reach 2 constricted by steep slopes with dense shrub layer.*

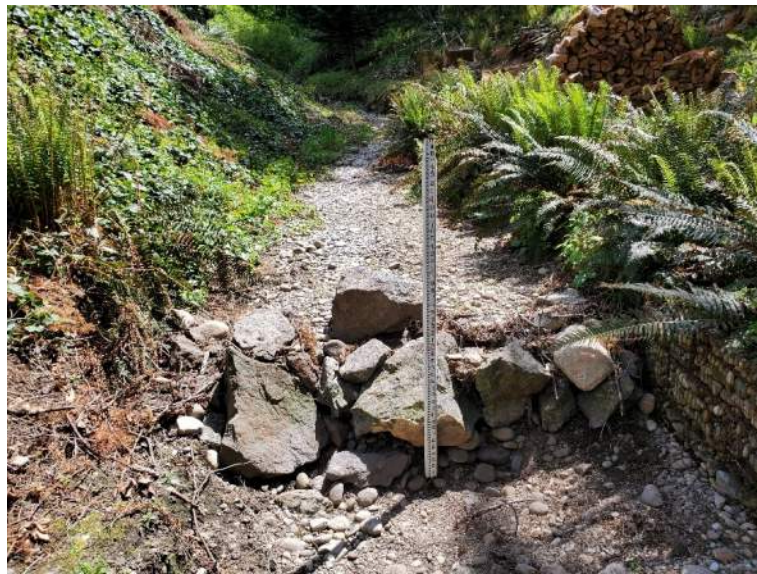
*Photo 14. Downstream portion of the Reach 2, modified with residential land use adjacent to the creek.*

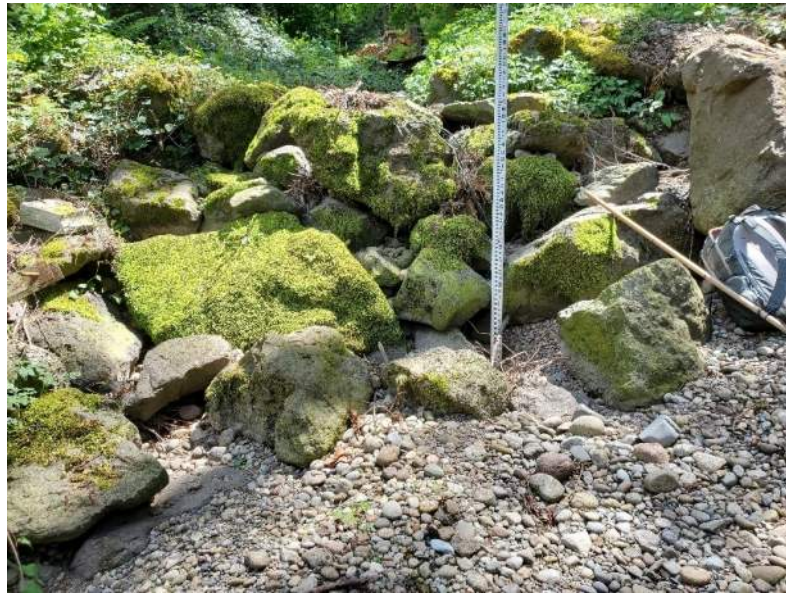
The lower 400 feet of this reach, which encompasses the remaining stretch of creek upstream of the South 302<sup>nd</sup> Street culvert (WDFW Crossing ID 991878), has been modified by landowners who have placed artificial grade controls to hold sediment. One grade control consists of a boulder and cobble step approximately 1-foot-high. Another consists of wooden slats held together and in place by metal fence posts protruding from the stream and is also about 1-foot-high. The last is a large band of rock that forms a cascade style step approximately 4 feet high at the lower end approximately 20 feet upstream of the culvert inlet (Photo 15). Landowners have also sought to hold the creek in place laterally by lining the banks with large rock or gabion baskets. This lower modified section is most likely acting as a transport reach at this time.

*Photo 15: Lower artificial grade control downstream of residential area.*

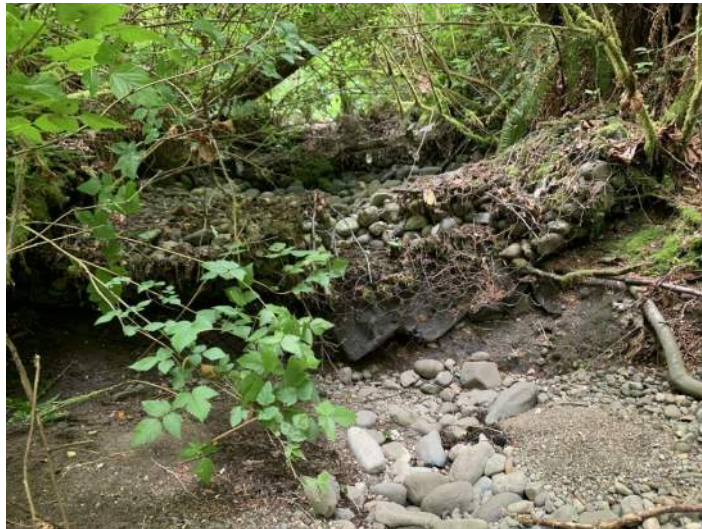
This section of Cold Creek is straight and has been highly modified. According to the PowellsWood website (PowellsWood Garden Foundation 2021), this area was significantly incised before the stream underwent restoration in the year 2000 to restore and hold grade. Large logs were squared, notched to concentrate low flow and placed perpendicular to the flow at approximately 15-foot intervals. Streambed material was brought in to refill the channel. It appears that most, if not all, logs are still in place. Some were buried while others have experienced lateral or vertical scour threatening to undermine them. Rock gabions downstream of the logs are commonly exposed (Photo 19). The last grade control forms a significant drop (Photo 20 and Figure 4).

*Photo 20: Last grade control series of gabions forming two 2-foot drops.*

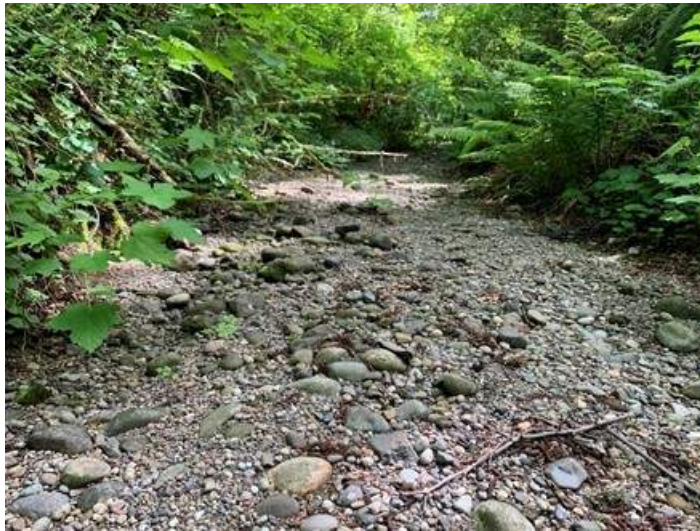
Deposition downstream of the last grade control structure is evident as this area is influenced by the unmapped culvert. The culvert at the downstream end of this reach is a 4-foot-diameter CMP encased in concrete. The opening is blocked by debris which stacks up sediment behind it, although the pipe is free of material (Photo 21). Medium to coarse sediment has accumulated downstream of the last grade control, filling the channel evenly such that the stream has no defined thalweg (Photo 22). Deposited material transitions to mainly sand within approximately 25 feet of the inlet.

*Photo 22: Sediment filled channel downstream of grade control but upstream of unmapped culvert.*

Spawning habitat capacity of the reach is limited by the frequency of larger cobbles, exposed geotextile fabric and relatively rapid succession of steps associated with the log weirs (Photo 23). The only large accumulation of gravel was observed at the very downstream end of the reach (Photo 22), near the inlet of a long barrier culvert that does not appear to span any infrastructure, nor is it listed on barrier inventory maps.

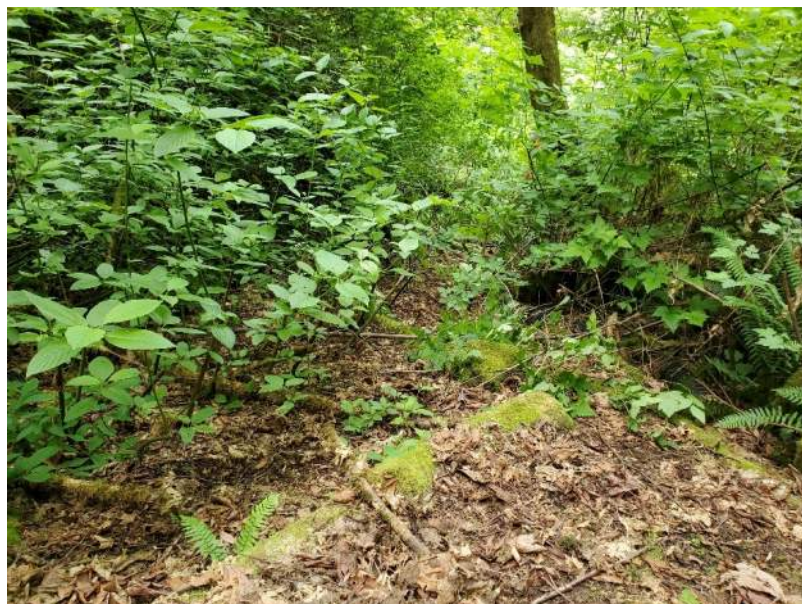
*Photo 28. Cut vegetation along evenly-graded slope adjacent to CMP uphill of manhole.*

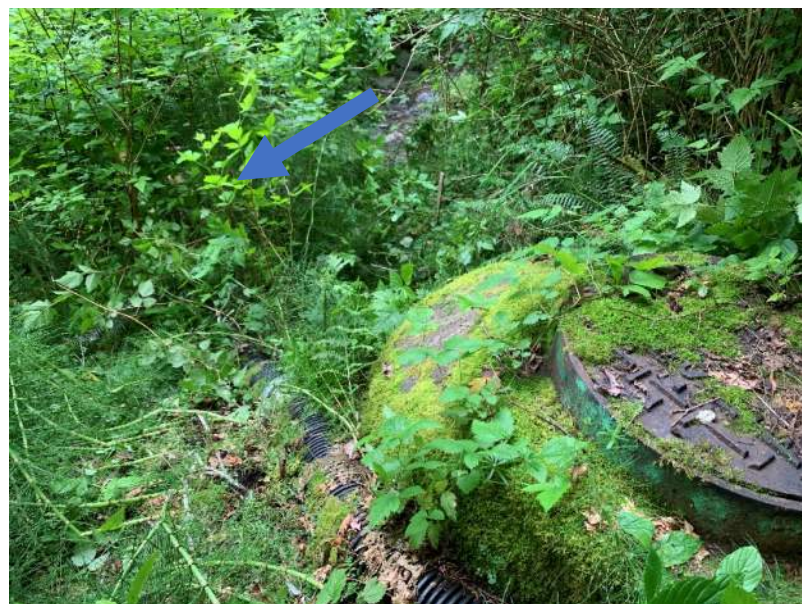
*Photo 29. Manhole adjacent to creek.*

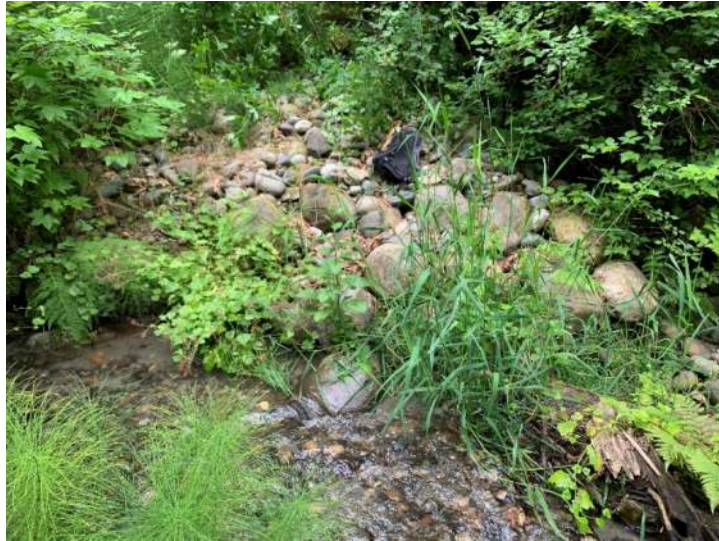
*Photo 30. Large rock placed along left bank below CMP outlet.*

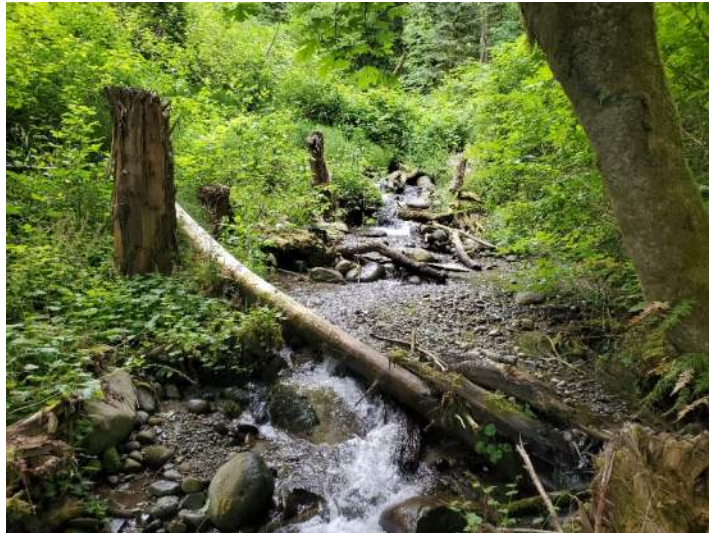
*Photo 31. Series of artificial steps and placed logs in creek near manhole/CMP outlet.*

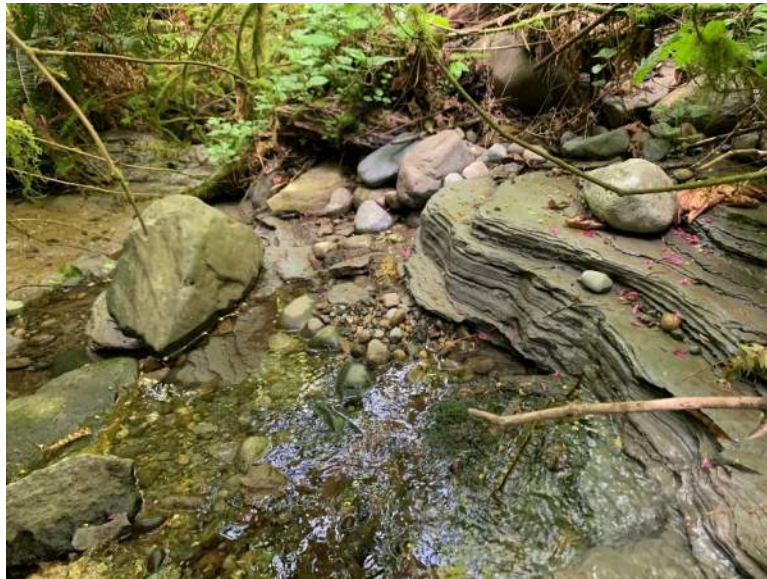
Throughout much of this reach, the channel incised in the past into the fine-grained material whether it is in-situ or slump blocks. However, more recent processes, from upstream to downstream, include incision, lateral scour and local deposition, mainly aggradation but some short stretches of vertical scour, and finally transport (Figure 5). Based on the long profile relative to the equilibrium slope, the first 300 feet downstream of the culvert may still be incising, due to a lack of sediment input as the upstream culverts have blocked much of the sediment being transported from upstream (Photo 33). Some valley widening may be occurring where less resistant beds of fine-grained material along the banks show signs of recent erosion (Photo 34).

*Photo 33: Looking downstream, stream appears to be downcutting into varved clays.*

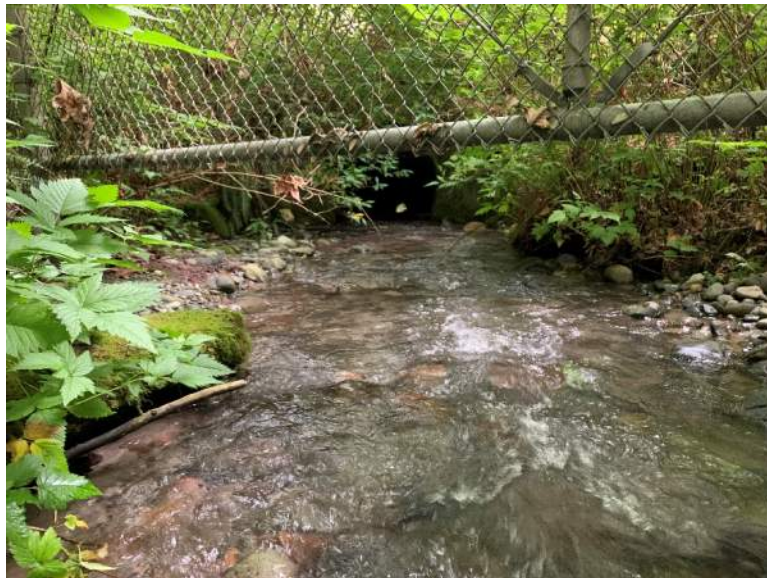
The section between Sta 1600 and the water treatment plant culvert at approximately Sta 1350 is downstream of the artificial steps and grade control associated with the manhole along the left bank. This reach is mainly a transport reach with minor local deposition upstream of logs in the creek.

*Photo 36: Transport reach to the culvert inlet at the water treatment plant.*

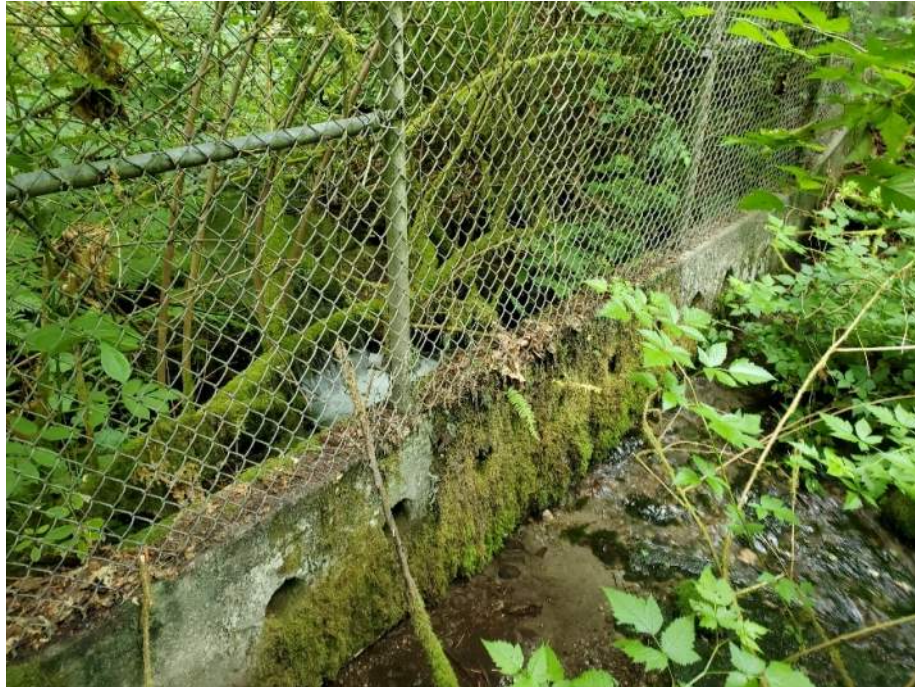
*Photo 40: Concrete dam downstream of weir.*

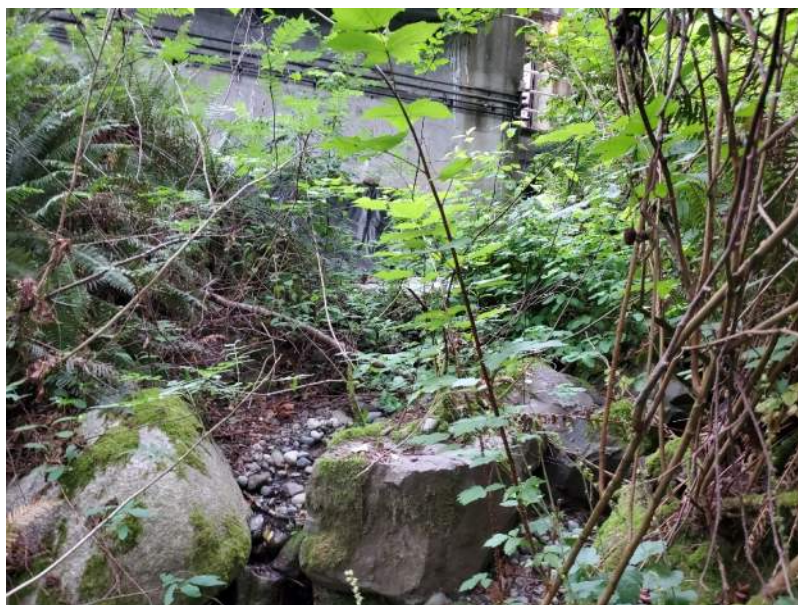
*Photo 42. Treatment plant directly adjacent to right bank.*

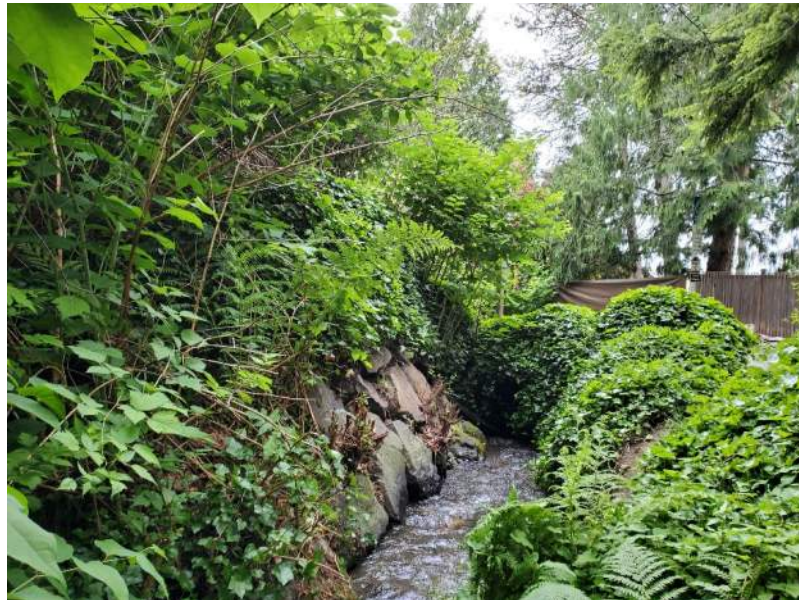
*Photo 43. Culvert at downstream end of reach with rock armoring and invasive species.*

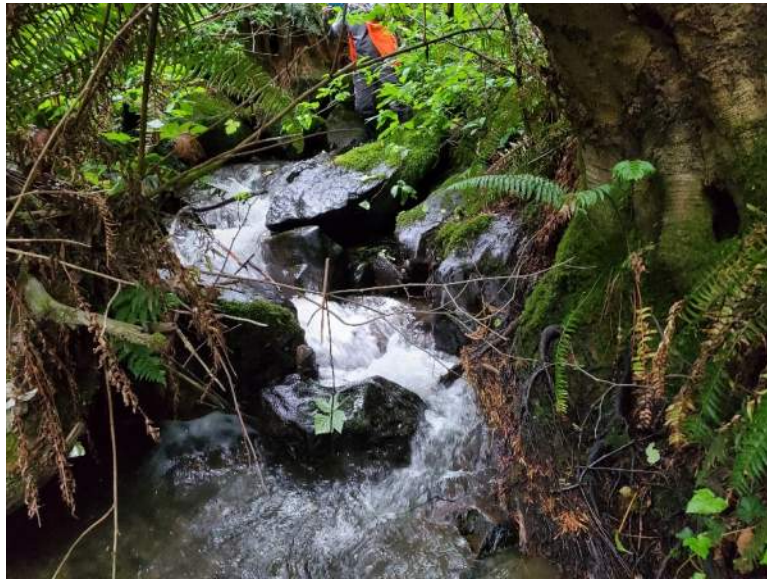
*Photo 45: Cascade downstream of outlet to culvert under treatment plant.*

This reach provides moderate rearing and regular stretches of potential spawning habitat (Photo 47). Pools are generally small and not particularly deep; however, often are well shaded and associated with LWM (Photo 48). LWM was present but less frequent within this reach compared to more natural, less developed areas upstream. A large rock cascade (Photo 45) likely limits passage in the upper  $\frac{1}{3}$  of the reach.

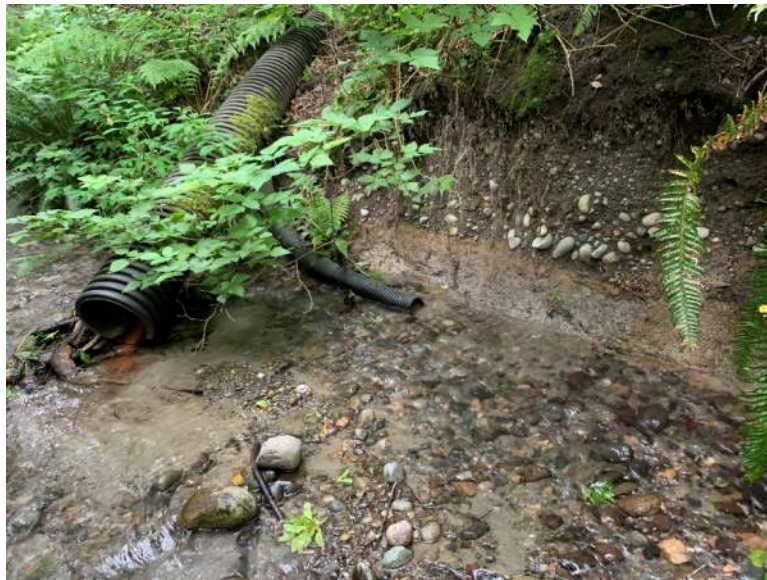
*Photo 46: Local lateral scour.*

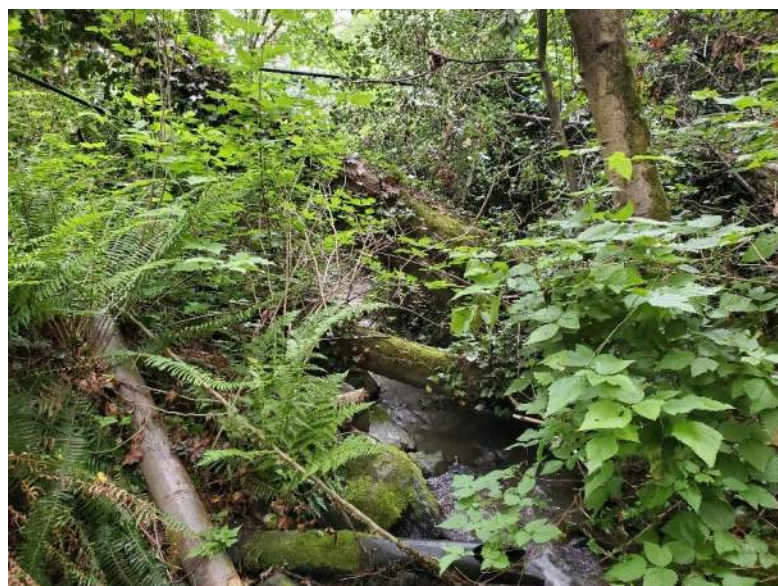
*Photo 48. Pool with overhanging LWM.*

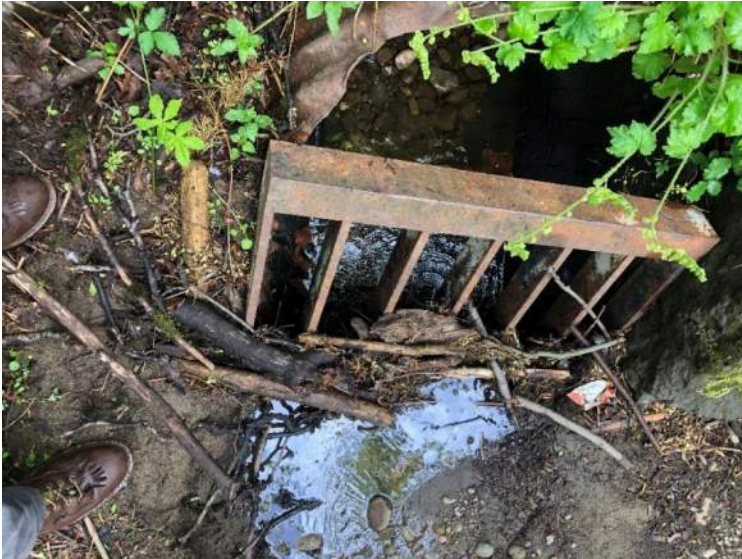
*Photo 1 SR 509 36" CMP inlet and steel grate. Stream bed is filled in ~18 inches above CMP invert.*

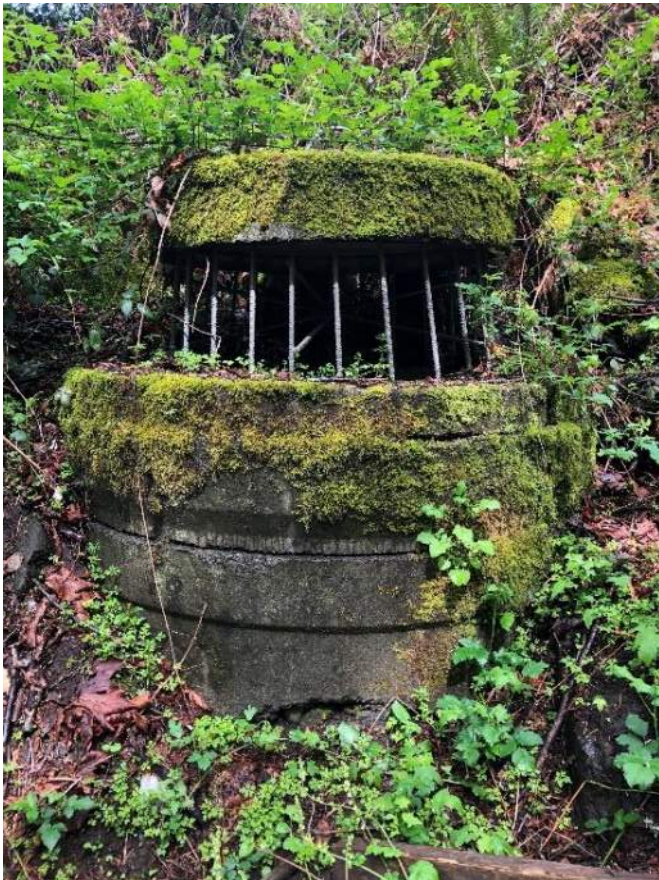
*Photo 2 SR 509 overflow inlet weir.*

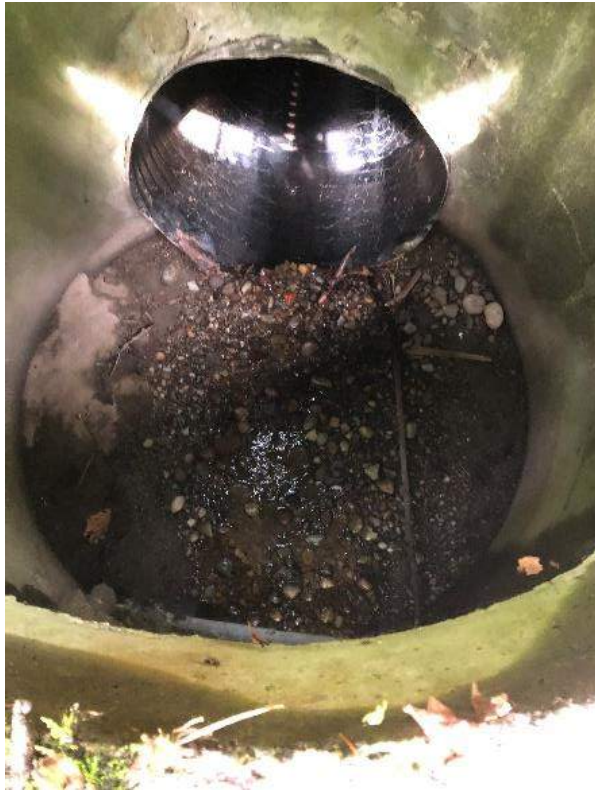
The overflow weir structure is a 48" Ø concrete manhole. The weir appears to be in good condition with a moss layer covering the exterior. The interior bottom is covered with a thin layer of sands and gravel. See photo 3.

The manhole outflow pipe is a 42" Ø CMP. This pipe is also covered with the same black tar coating. The pipe is in generally good condition with minor damage to the coating on the front edge of the pipe. The bore of the 42" Ø CMP was straight and appears clean and free of debris or other damage. See photos 3, 4 and 5.

*Photo 3 SR 509 View inside overflow weir and 42" CMP out flow.*

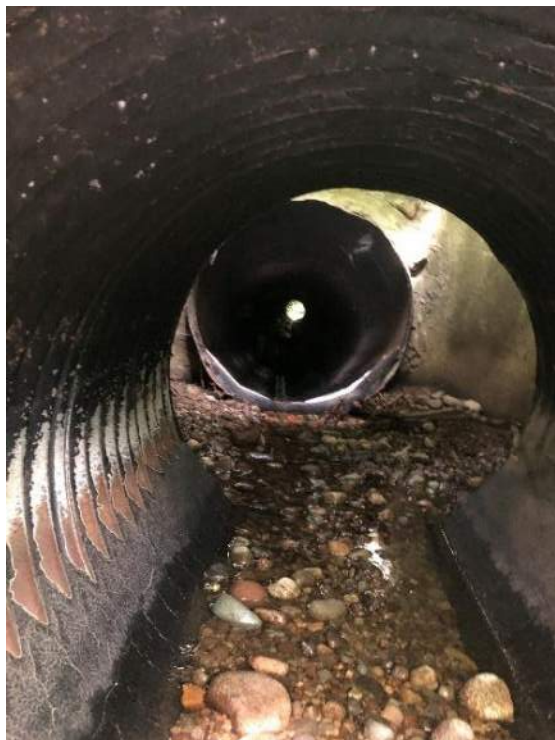
the pipe invert against the steel grate. The pipe is coated with a black asphalt coating. The sides of the pipe at mid height are missing this coating with a light buildup of surface corrosion. The invert in the 36" Ø CMP has a layer of sand and small gravel wash that remains from a previous flow. See photos 4 and 5.

*Photo 4 SR 509 View looking thru 36" CMP at inlet of 42" CMP.*

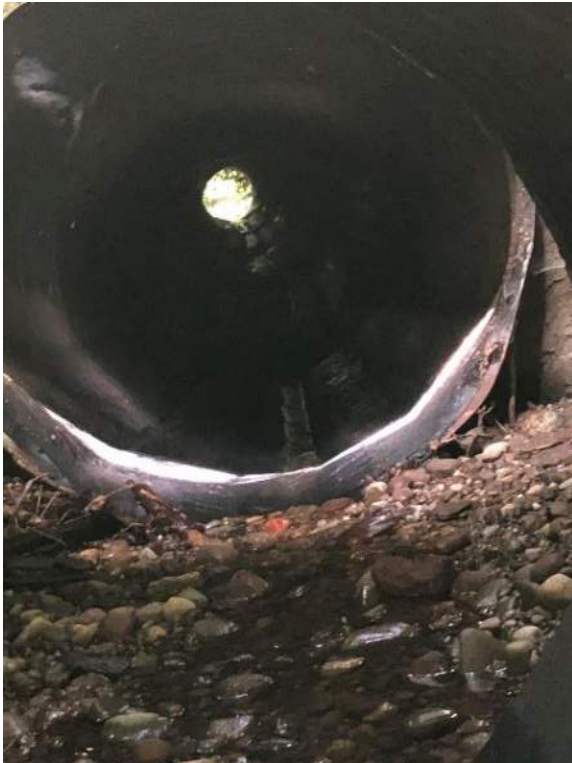
*Photo 5 SR 509 View inside 36" CMP inlet looking at/thru 42" CMP.*

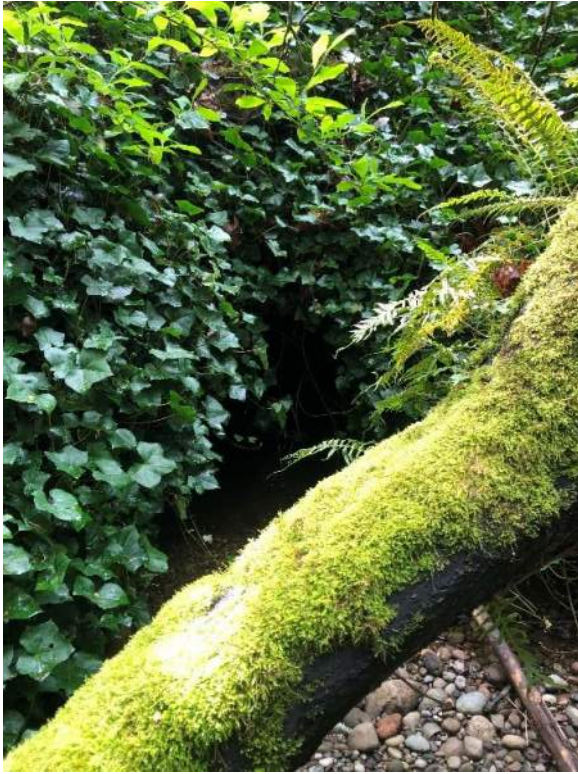
The 42" Ø CMP outlet is covered in vegetation (Ivy) and a large tree has fallen over top of the outlet but has not damaged the apron or restrict the water flow at this time. See photos 6 and 7. The outlet has a 9-foot-wide concrete apron with an 18" tall flow energy dissipation wall. The flow is hitting the wall with enough velocity to cause erosion of the embankments on both sides of the stream. The apron slab is also perched about 18" above the stream bed at the downstream face. The apron is exposed on all three sides with heavy riprap present. See photos 8 and 9.

*Photo 7 SR 509 42" CMP outlet.*

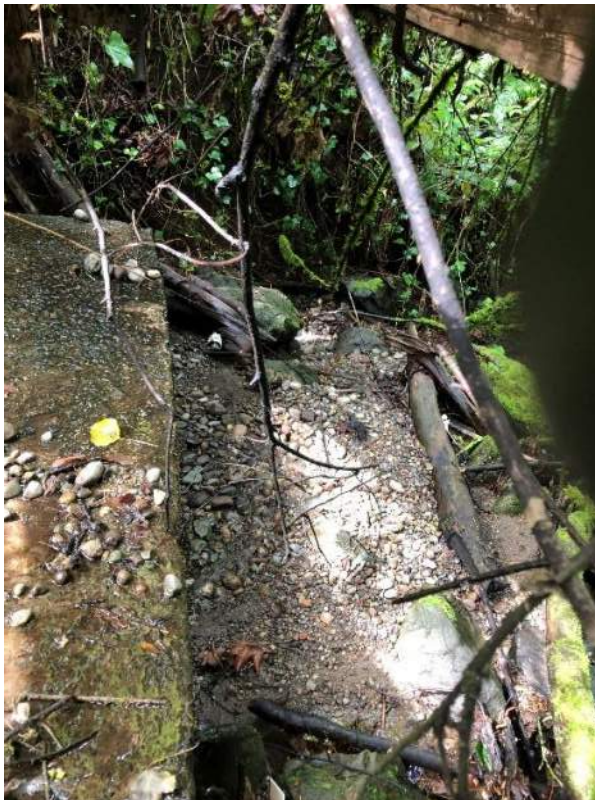
*Photo 8 SR 509 Outlet slab perched end.*

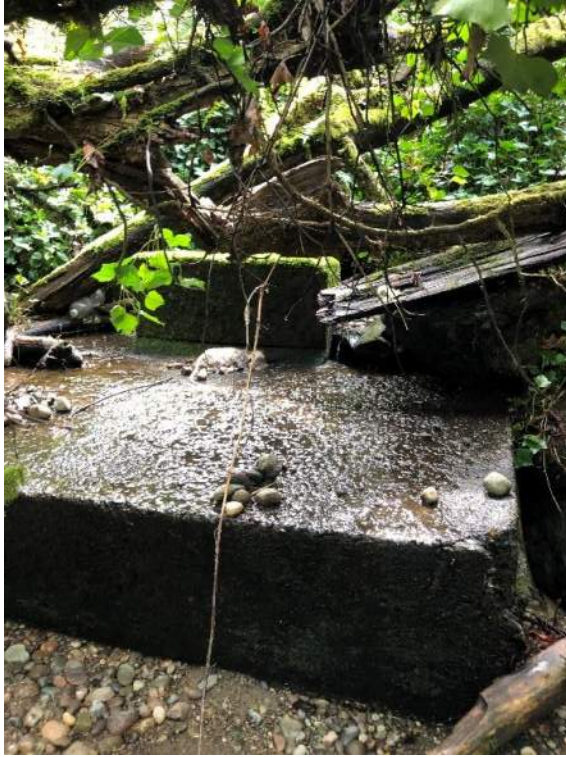
*Photo 9 SR 509 perched outlet slab and flow dissipater wall.*

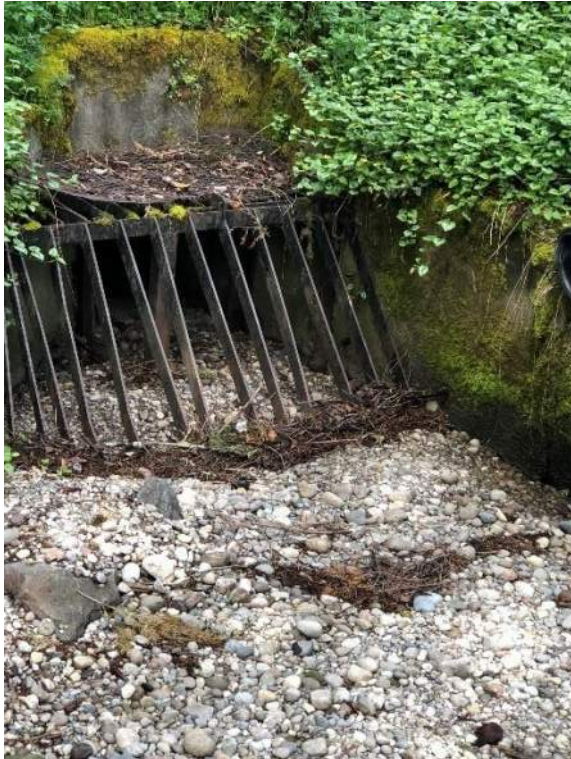
*Photo 10 Marine Hills ID 19017 Inlet and steel grate cover.*

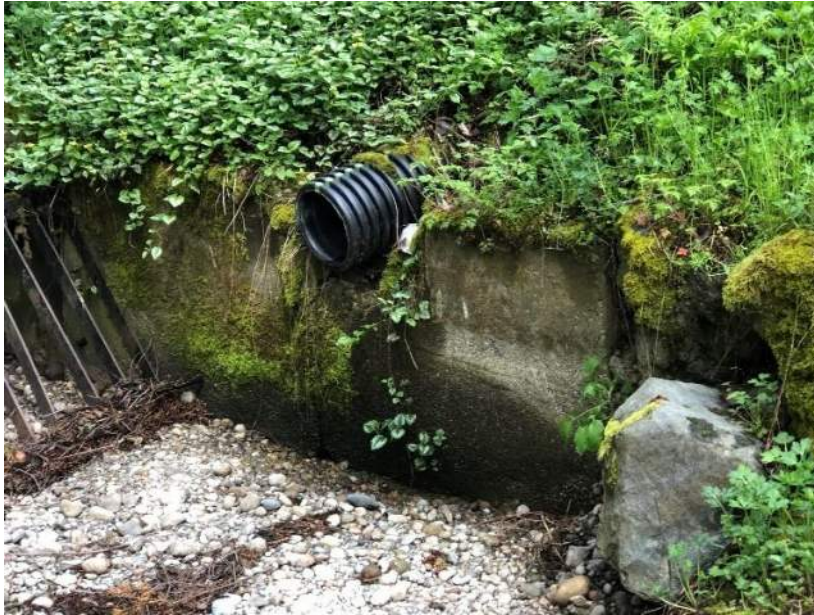
The first segment of the culvert is constructed of a 36" rectangular four-sided cast-in-place concrete box culvert. The inlet is covered with a steel grating and has a head wall on the righthand side. The head wall top is cut to fit a 12" Ø drainpipe. The wall has a substantial ¼" vertical crack adjacent to the pipe cutout. The upstream half of the wall is broken with ½" outward tilt into the stream. See photos 10 and 11. There was one video provided, dated March 30, 2021 (length of 4.82 minutes), which was reviewed for the internal culvert condition. This video demonstrated longitudinal cracks in the walls that appear to be related to concrete cold joints created at the time of construction. There are numerous spalls with exposed and lightly corroded reinforcement bars in the box ceiling. The culvert bottom slab is unreinforced concrete with exposed aggregate. This culvert may have originally been constructed as three sided and a bottom slab added after the walls were constructed. At about 8 feet in from the inlet the concrete floor is broken up as there are pieces of concrete slabs/chunks present in the bore. See photo 12.

As a result of the bottom slab damage this portion of the culvert has a culvert condition code of 3 “severe” deterioration because of the broken bottom slab. The headwall damage is also in this category but is not deemed as significant to the culvert function.

*Photo 11 Marine Hills ID 19017 Headwall at inlet.*

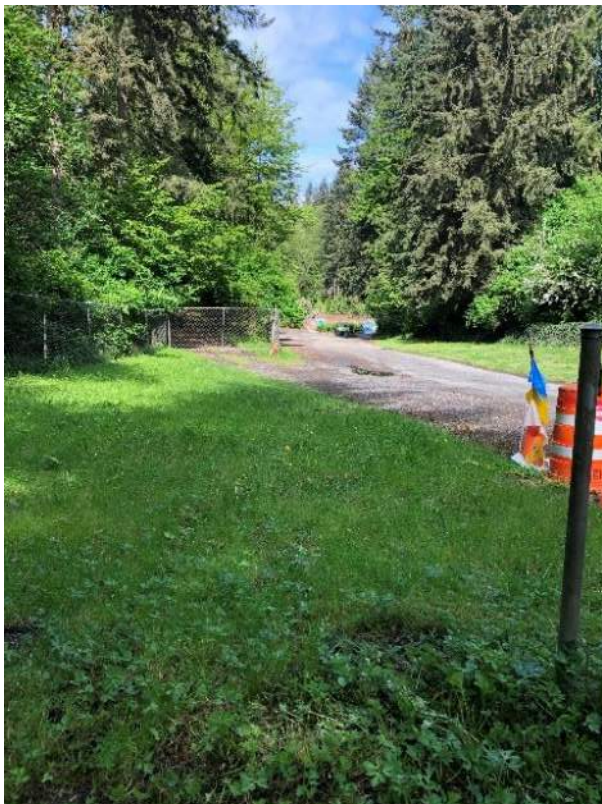
*Photo 17 Asset ID 19021 looking west from inlet (adjacent to pool gate) along alignment towards pool and segment outlet.*

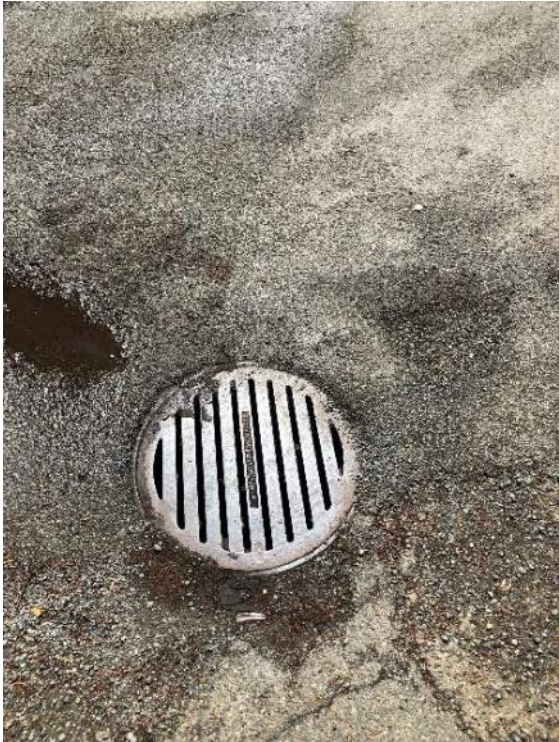
*Photo 18 Asset ID 19021 to 21522 catch basin structure in pool west end of parking lot.*

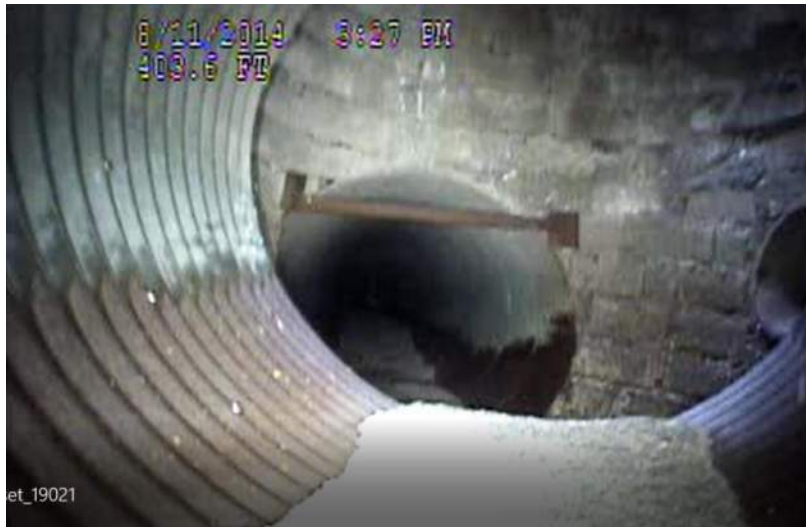
A 2-foot drop exits into the downstream manhole. See photo 19.

*Photo 19 Asset # 19021 spring line drop into outlet manhole, approx. 2-foot drop.*

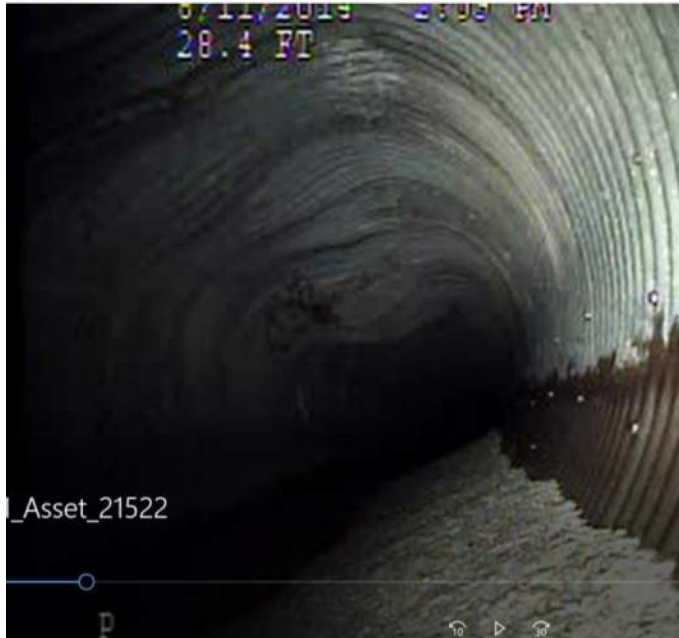
There are areas of damage to the crown that is displayed in each of the videos. The first damage occurs between 20 to 45 feet into first the segment. See photo 20. The crown is crushed in about 12 inches. At 40 feet into the first segment of the culvert, there is heavy damage and a hole torn into the crown. See photos 21 and 22. It looks like an excavator dug into and tore the CMP. The damage is unrepaired and looks to have been covered with additional sheet metal. Dirt and boulders are visible thru the opening around the perimeter of the torn hole.

*Photo 20 Asset ID # 21522 crushed CMP crown at ~22 feet.*

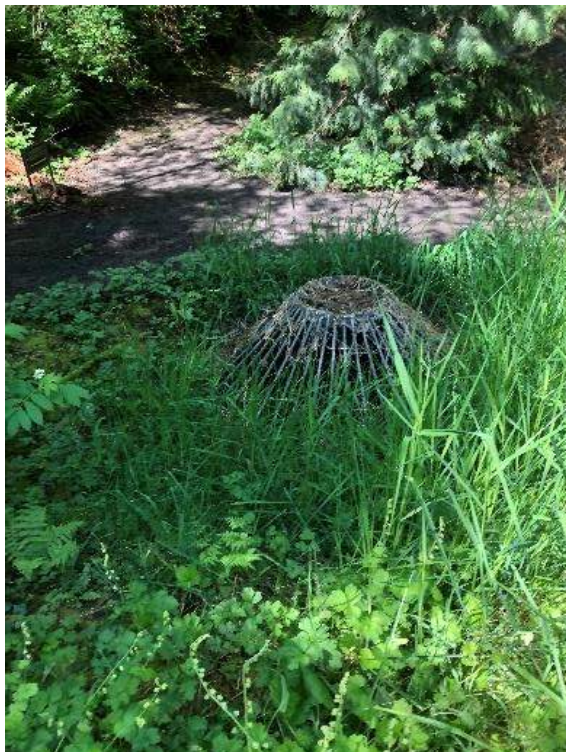
*Photo 23 Catch basin/inlet between Asset ID # 21522 and ID # 21523 west of pool.*

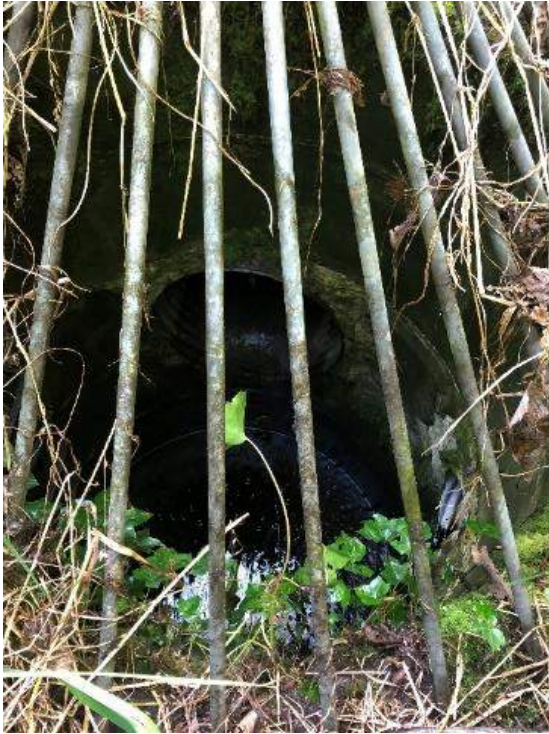
*Photo 24 Asset ID # 21522 outlet CMP at manhole between Asset ID # 21522 and ID # 21523.*

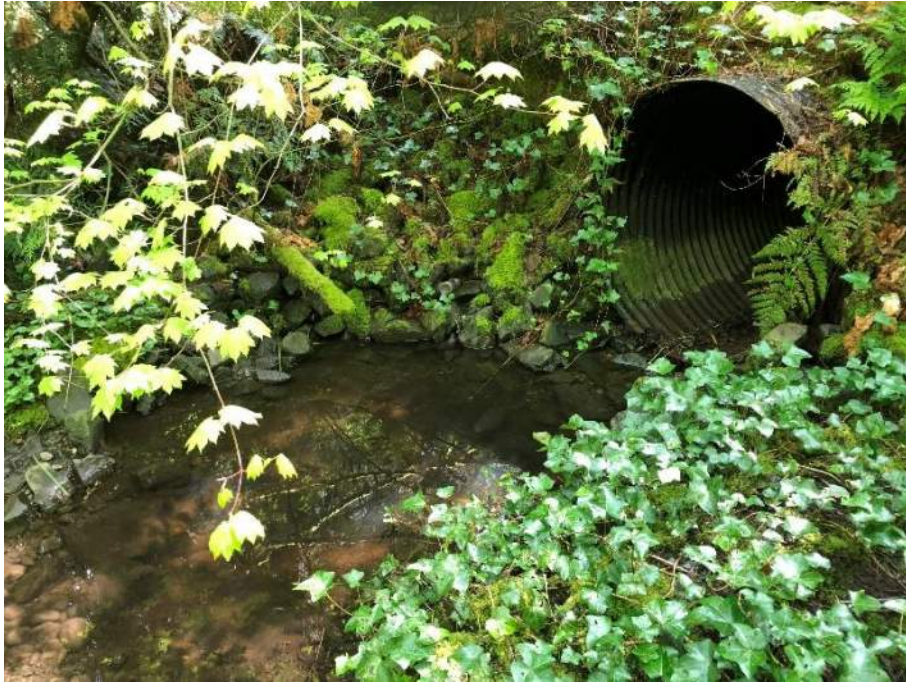
This segment of the culvert is constructed of 42” Ø Galvanized CMP with an unknown length but relatively short (~50 lineal feet). This segment is enclosed by a manhole at the inlet and is open to the creek channel at the outlet. The entire length of the culvert can be seen thru the outlet. See photos 26 and 27. The CMP is in good condition with light surface corrosion on the invert. The assessment this segment is rated at a culvert condition code of 7.

*Photo 26 Outlet Asset ID 21523.*

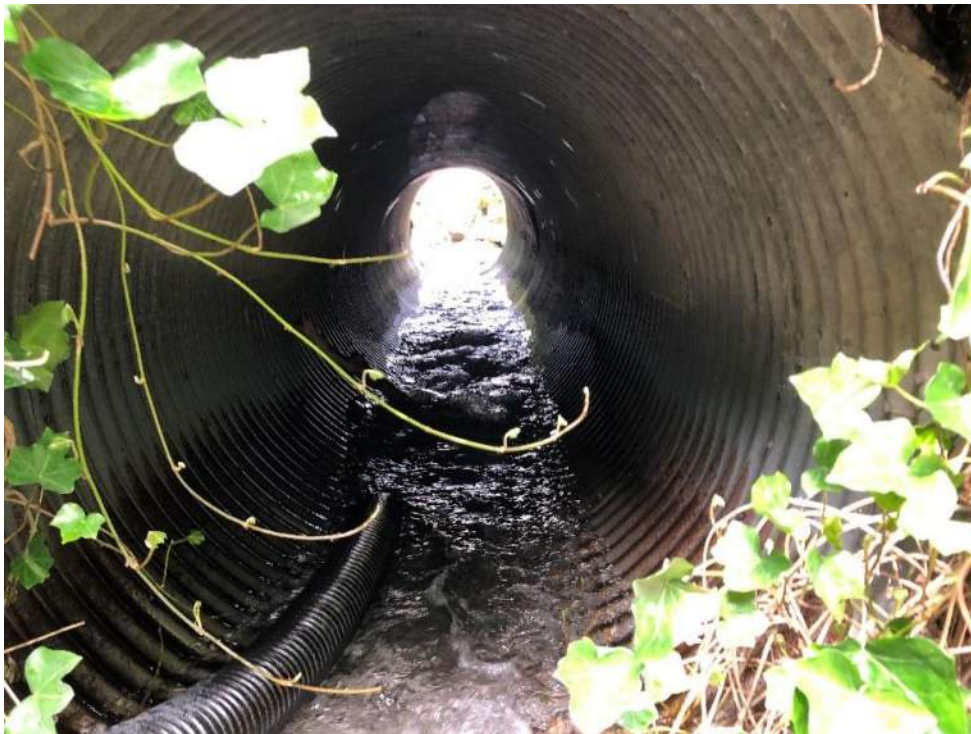
This culvert is within the city of Des Moines and was reviewed for a structural safety inspection only. The inspection consisted of a visual assessment looking through each end of the CMP. The culvert is a 48" Ø Galvanized CMP pipe. It is about 30 lineal feet long. The bore and alignment are straight. There is light corrosion in the bottom 1/3 of the bore. The stream makes a hard turn at the entrance to the inlet of about 20 degrees. The left-hand side of the embankment is the bottom of a built-up stacked boulder wall. The driveway over the culvert was new asphalt indicating there may have been some over topping or washing of the roadway recently. The outlet pipe is squished vertically to about 30" wide at mid-height. See photos 28 to 30. No significant structural deficiencies were noted.

*Photo 29 Redondo Shores Dr. S. inlet and CMP bore.*
