## **Basin Study and Prioritization Report**

Cold Creek Culvert Replacements and  
Channel Stabilization Project  
Federal Way, Washington

*for*  
**City of Federal Way**

April 18, 2022

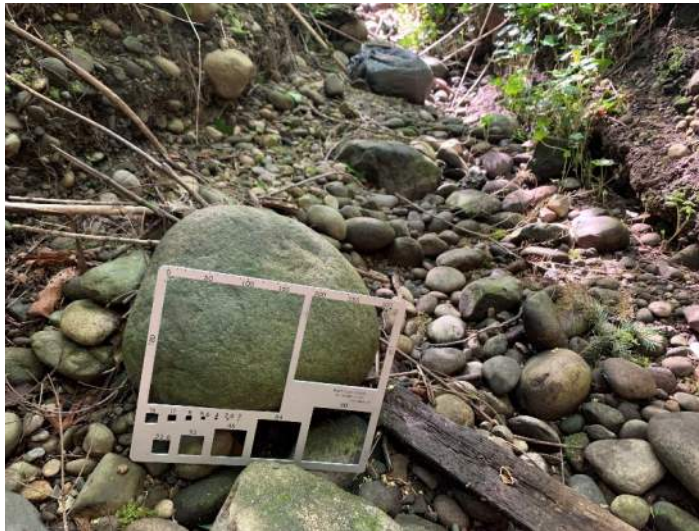
The sediment in the channel near the stormwater outlet appeared more angular than typical for streambed material, suggesting it was added to the system at some point in time (Photo 6). Elsewhere, bed material appears to have been derived naturally and ranges from coarse sand to boulders with large gravel as the dominant material (Photo 7). There was a clear deficiency of fine-grained material in the bed material even though it is abundant in the banks, suggesting fine material is easily carried out of this upper portion of the system.

*Photo 7: Boulders and smaller rounded material.*

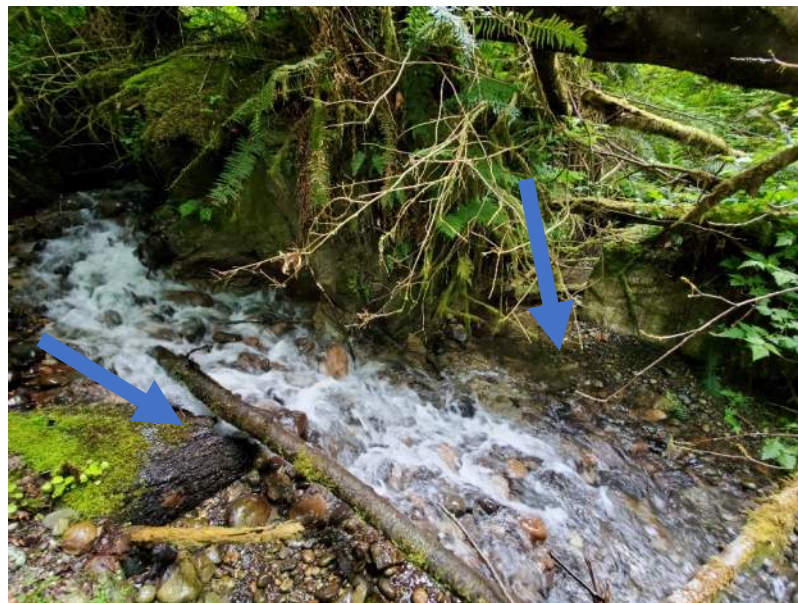
*Photo 27. Tributary input (left) contributing roughly equal flow to mainstem (right).*

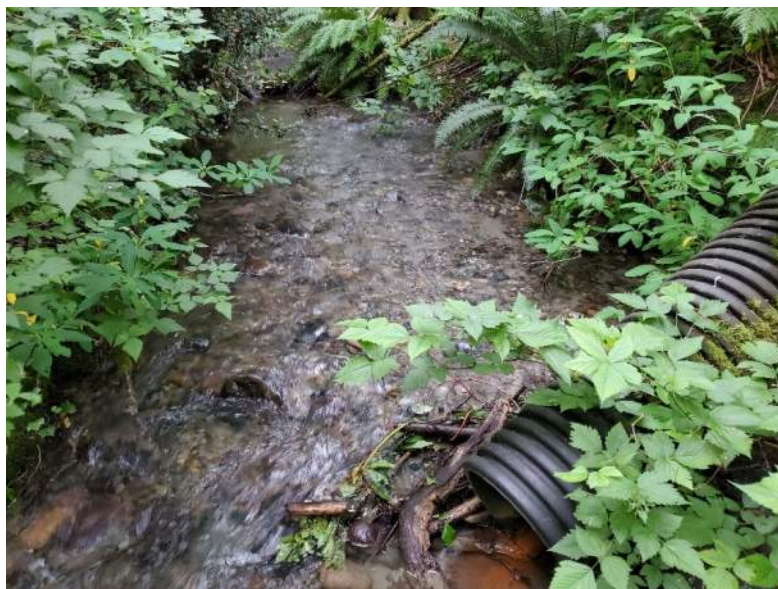
This reach provides moderate rearing and regular stretches of potential spawning habitat (Photo 47). Pools are generally small and not particularly deep; however, often are well shaded and associated with LWM (Photo 48). LWM was present but less frequent within this reach compared to more natural, less developed areas upstream. A large rock cascade (Photo 45) likely limits passage in the upper  $\frac{1}{3}$  of the reach.

*Photo 47. Potential spawning riffle upstream of stormwater pipe input.*

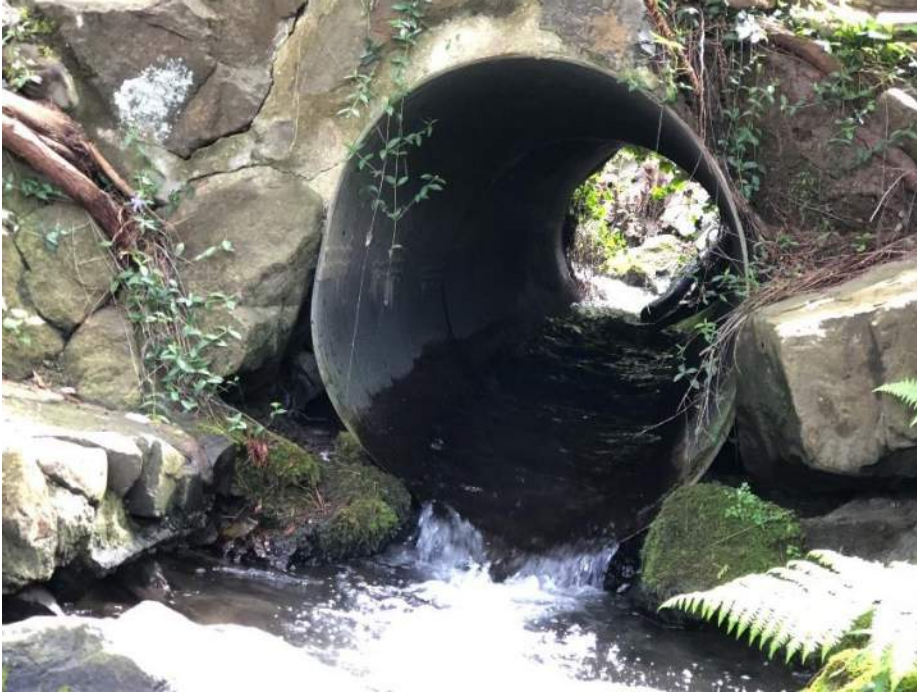
This culvert is within the city of Des Moines and was reviewed for a structural safety inspection only. The inspection consisted of a visual assessment looking through each end of the CMP. The culvert is a 48" Ø Galvanized CMP pipe. It is about 30 lineal feet long. The bore and alignment are straight. There is light corrosion in the bottom 1/3 of the bore. The stream makes a hard turn at the entrance to the inlet of about 20 degrees. The left-hand side of the embankment is the bottom of a built-up stacked boulder wall. The driveway over the culvert was new asphalt indicating there may have been some over topping or washing of the roadway recently. The outlet pipe is squished vertically to about 30" wide at mid-height. See photos 28 to 30. No significant structural deficiencies were noted.

*Photo 30 Redondo Shores Dr. S. outlet.*

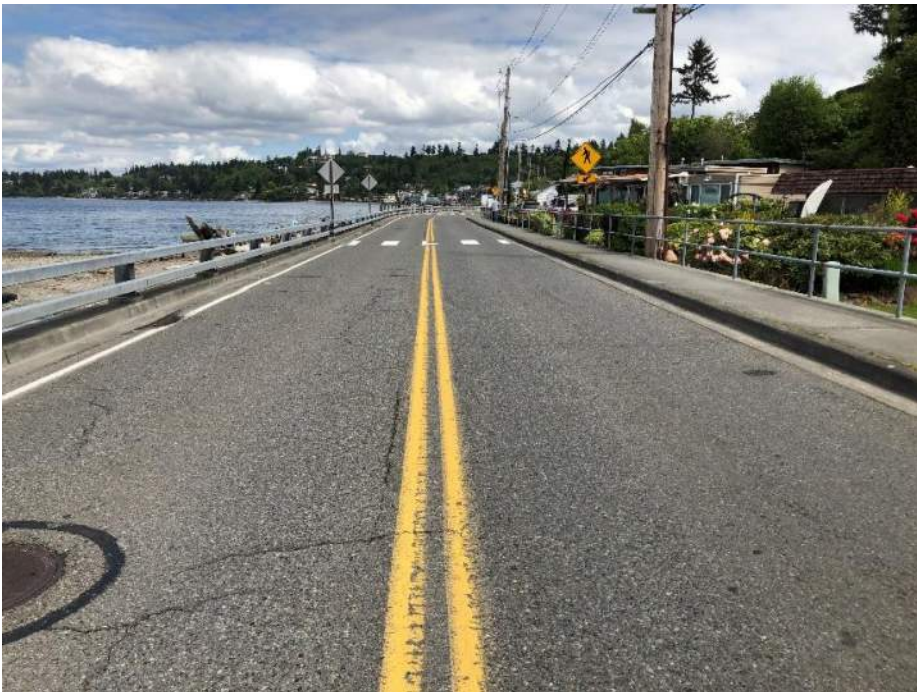
This culvert is owned by the city of Des Moines and was reviewed for a structural safety inspection only. The inspection consisted of a visual assessment looking through each end of the box culvert. The culvert is made up of cast-in-place concrete three-sided box (a bottom slab was not visible at the time of the inspection) with a span of 5'-0" and overall length of 30 lineal feet. See photos 31 and 32. The roadway consists of two travel lanes, 5'-6" sidewalk on the eastside and a 19" curb on the westside (bay side). The outlet is covered by a bulkhead that extends below the slab soffit by 18". This leaves about 12" to the stream bed. This material is beach sand and is highly transportable. The inlet water surface elevation at the time of the inspection was located 50" below the top of curb/sidewalk providing a vertical opening of 38". No significant structural deficiencies were noted.

*Photo 31 Redondo Beach Dr. looking NE. culvert location before crosswalk.*
